INVESTIGATION REPORT

8/14/2012

Shell Oil Products US Martinez, California Refinery Flexicoker Gas Plant Debutanizer Leak to Atmosphere

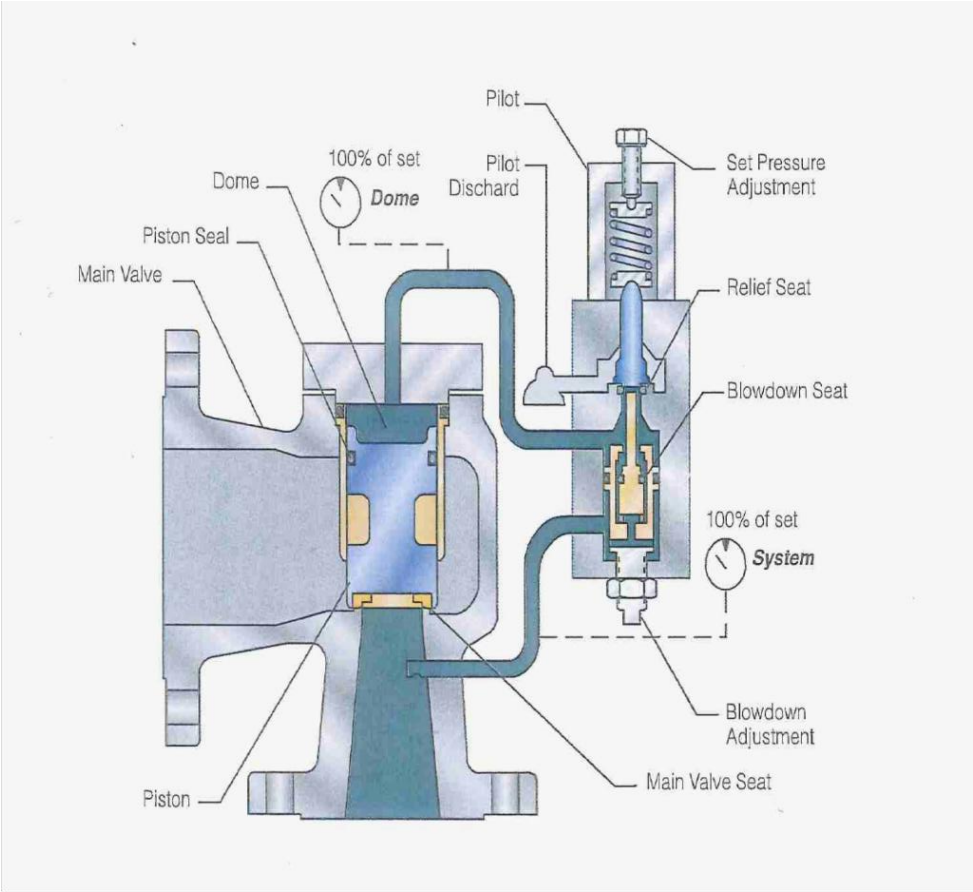
Figure 1: Anderson Greenwood Series 200 Pop Action PSV.

well below the set pressure. SVJ-197 is a pop action valve, meaning that it is designed to be leak tight to within +/- 5% or better of its set pressure. Figure 1 shows the main parts of the PSV.

Immediately after the leak, SVJ-197 was removed from the column and tested to see if it would relieve at the set pressure. On the test stand however, the valve was found to be leaking in the main seat area to the extent that a pressure test could not be performed. The valve was then carefully disassembled with observers from the investigation team present. Overall the following observations were made:

1. The tubing pieces which are necessary for communicating the process pressure to the top of the main seat or “dome” section as well as the pilot were found to be clear and tightly attached with no leaks.
2. The main valve seat, which was made of viton, was found to be significantly deteriorated. Its condition was such that it could not form a seal against the nozzle seat surface.
3. The pilot and main valve seat springs were found to be in acceptable condition, with no breakage or corrosion present.
4. The pilot piston and main piston o-rings were in acceptable condition.
5. The pilot piston and the main valve piston were found to be acceptably clean and there was no evidence of significant binding.
6. The filter between the tubing pieces from the process and the pilot had no liquid in it but it was slightly dirty. The amount of dirt would not have affected flow through the filter.

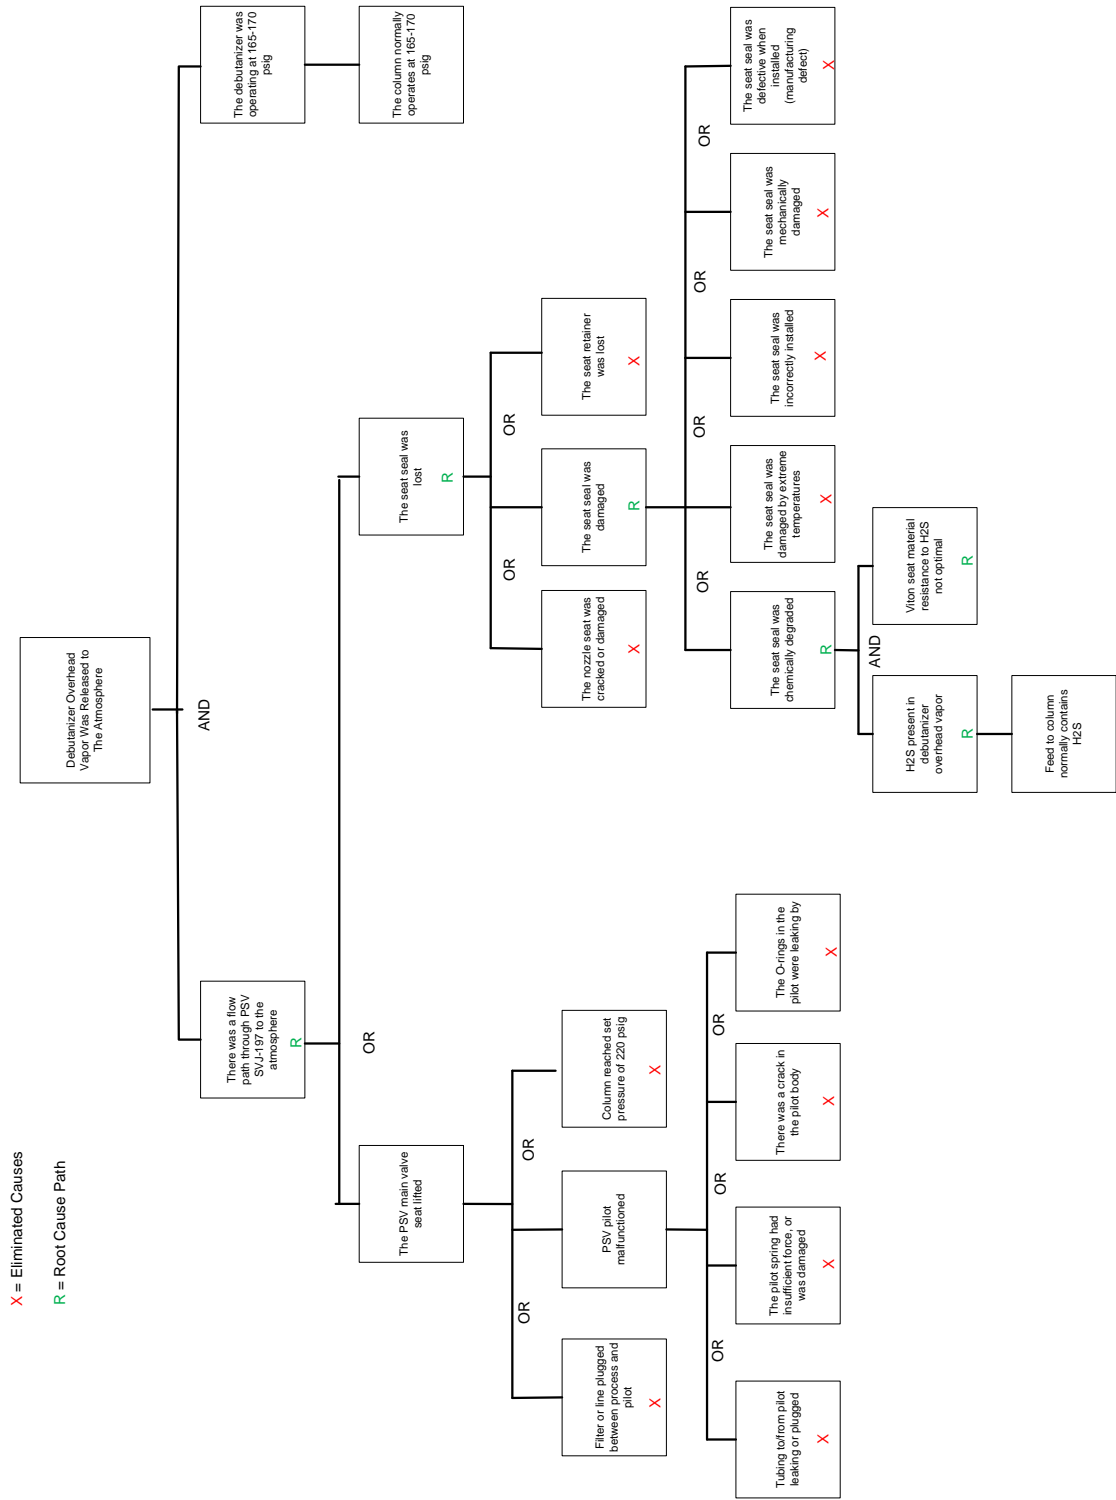
Figure 2: Flexicoker Gas Plant Debutanizer Leak to Atmosphere Cause and Effect Diagram
 Incident Date 8/14/2012

The investigation team considered possible causes of why the release of vapor could have occurred through SVJ-197. These are shown on a cause and effect diagram (Figure 1) prepared by the team. Based on the review of the process data and the post-incident inspection, the investigation team found that SVJ-197 was operating as designed until the leak in the main seat developed. The evidence indicated that the valve did not relieve below its set pressure, but rather that the main valve seat began to leak while the main valve piston was being held in its usual closed position by the pilot.

The root cause of the leak was the deterioration of the viton main seat in SVJ-197. The deterioration was probably caused by the presence of H₂S in the debutanizer overhead stream, which, over time caused a breakdown in the viton seat. The investigation team did not find any causes related to latent conditions for this incident (Table 1).

Recommendation	Responsible Manager or Individual	Estimated Completion
1. For SJV-197, install a new soft goods kit including a main seat with increased H ₂ S resistance during the August 2012 Flexicoker Turnaround	Operations Central Pressure Equipment Engineer	November 1, 2012
2. Review chemical resistance of soft goods for all PSVs relieving to the atmosphere. Verify that the chemical resistance of the soft goods are optimal for the service.	Pressure Equipment Integrity Department Manager	June 30, 2013
