**ATTACHMENT B**  
**72 HOUR FOLLOW-UP NOTIFICATION REPORT FORM**  
**CONTRA COSTA HEALTH SERVICES**

**Rodeo Refinery  
Tank 294 Over-Pressure 061512-1  
July 13, 2012**

**Incident Investigation Report**

### **RODEO REFINERY- Tank 294 Over-Pressure Incident**

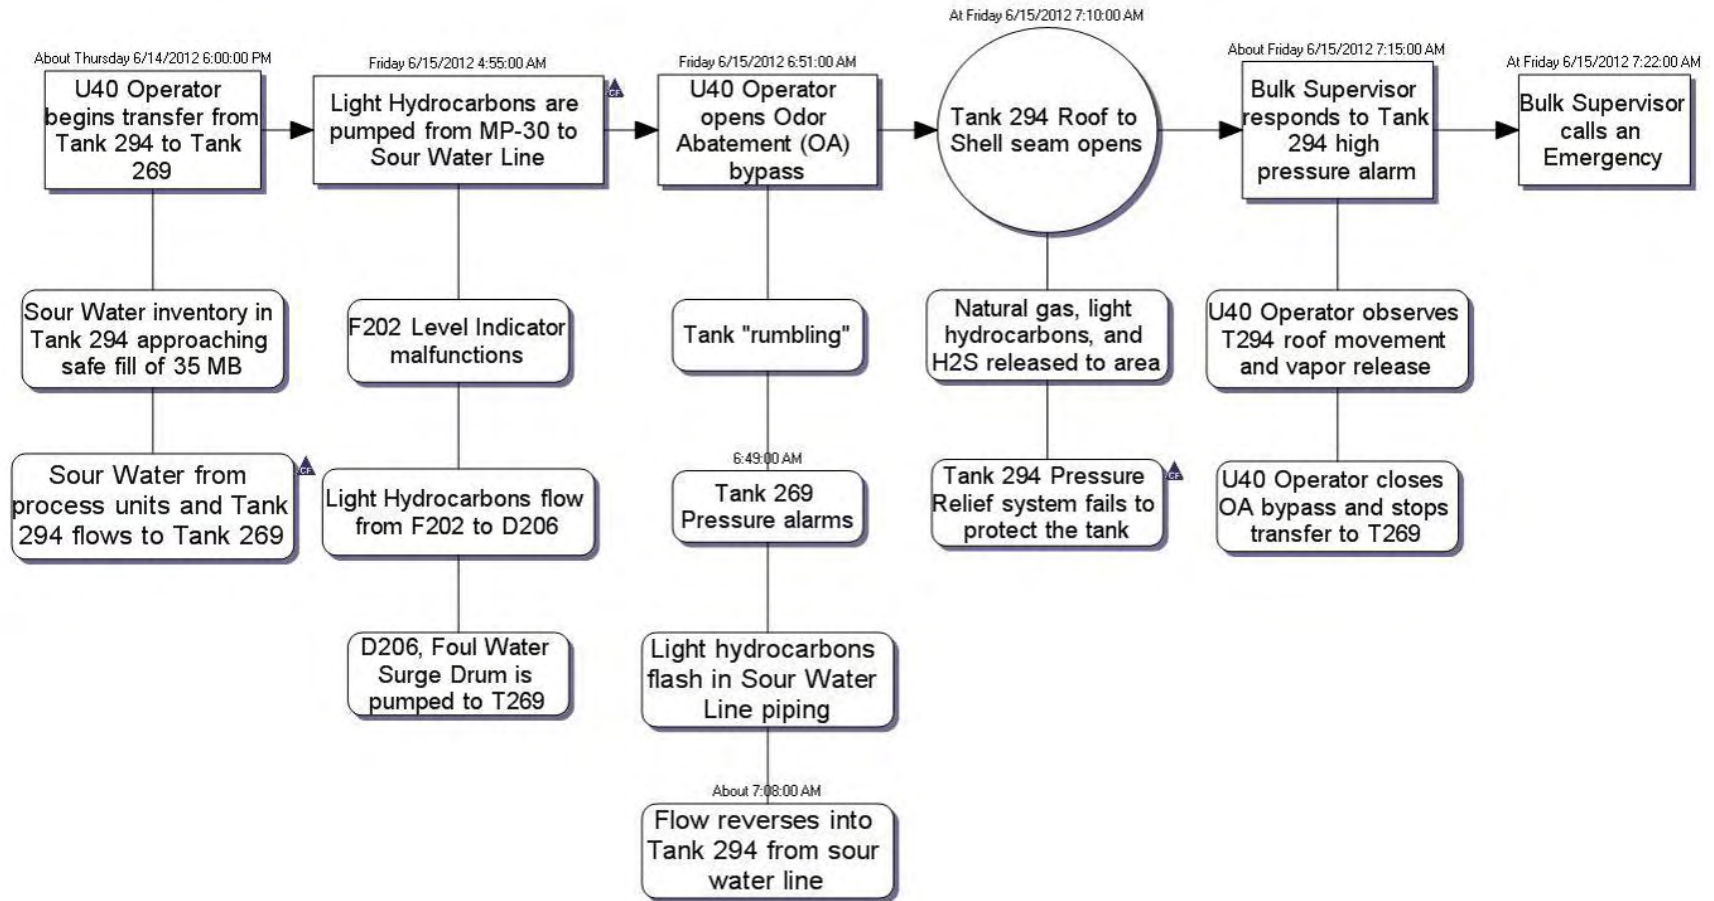
ATTACHMENT 1 - TapRoot® Root Cause Analysis SnapChart®

- 1) Sour Water from process units and Tank 294 flows to Tank 269
  - a. Procedures- Not Used/Not Followed- No Procedure
  - b. Management System- Standards, Policies, or Administrative Controls Not Used- No way to implement
- 2) Light Hydrocarbons are pumped to Non-Phenolic Sour Water Tanks
  - a. Management System- Standards, Policies, or Administrative Controls Not Used- Accountability Needs Improvement
  - b. Management System- Corrective Action Needs Improvement
  - c. Management System- Corrective Action- Trending Needs Improvement
- 3) Tank 294 Pressure Relief System did not protect the tank
  - a. Equipment Difficulty- Design Review- Hazard Analysis Needs Improvement

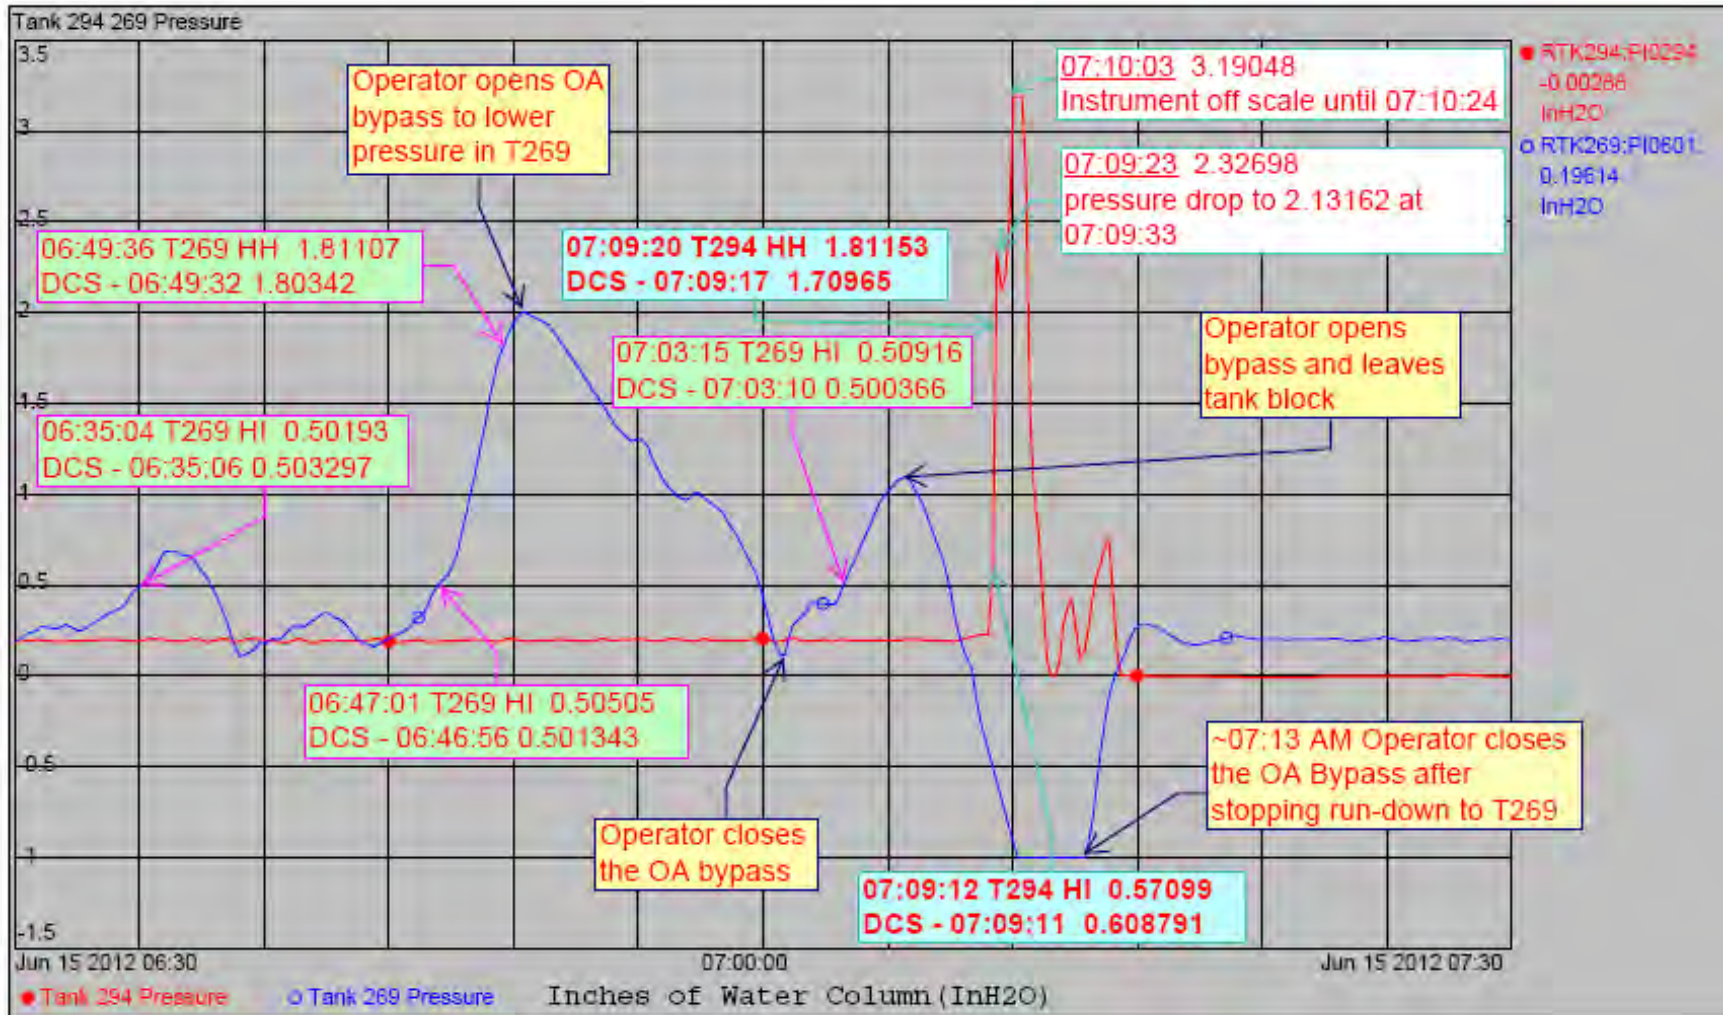
# ATTACHMENT 3 Tank 269 and Tank 294 Pressure Trends

The amount of light hydrocarbon material pumped from the D206 to Tank 269 began increasing at approximately 5 a.m. At first the Odor Abatement system handled the increased vapor from the light hydrocarbons. At approximately 6:30 a.m. the pressure began to rise in the tank. A high pressure alarm for Tank 269 sounded at the Sulfur Plant Operator console.

The high pressure alarm was received by the Sulfur Plant Operator, who contacted the U40 Operator and Shift Supervisor to inform them of the high pressure alarm on Tank 269 at approximately 6:40 a.m. The U40 Operator responded to the call and upon arriving at the tank noticed the tank pressure at 1.98" Water

After observing the Tank 269 pressure decrease back to normal operating range, the U40 Operator closed the pressure control bypass. Tank 269 pressure immediately began to increase again. The U40 Operator responded by opening the bypass again at 7:06 a.m. He then walked to an adjacent roadway to meet with the Shift Supervisor.

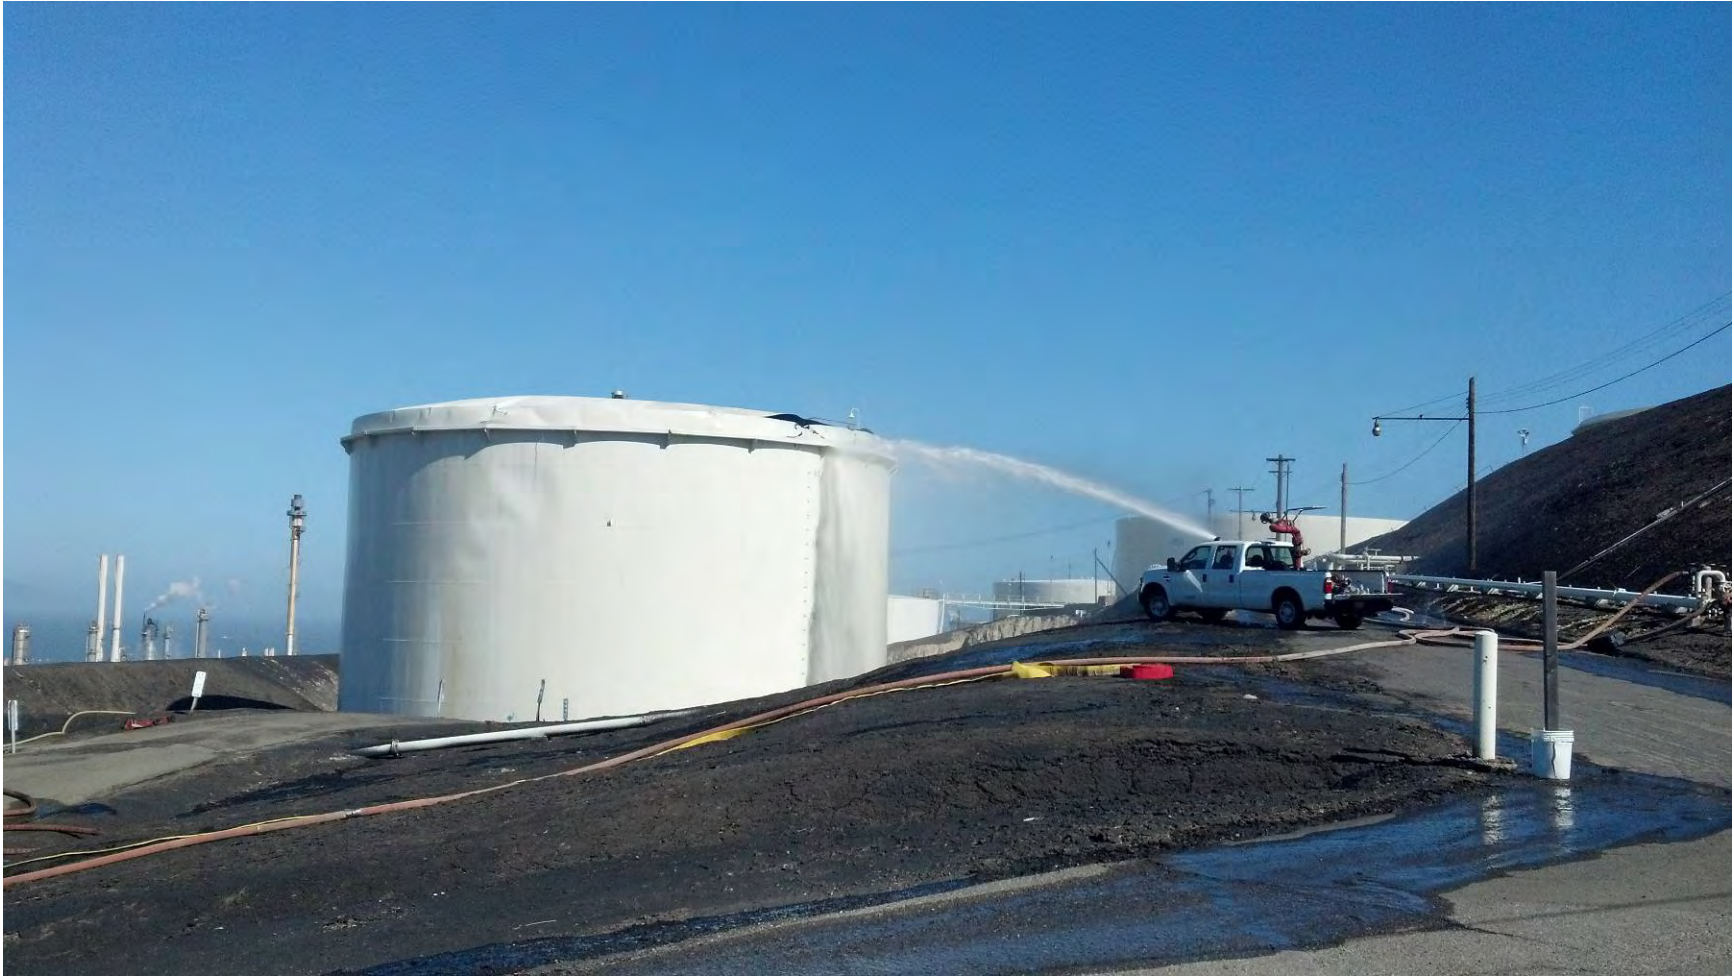
This over-pressure caused a separation in the tank roof to shell seam. The roof to shell opening released a combination of the natural gas blanket, light hydrocarbons and hydrogen sulfide vapors to atmosphere.

Tank 294 during the initial emergency response.

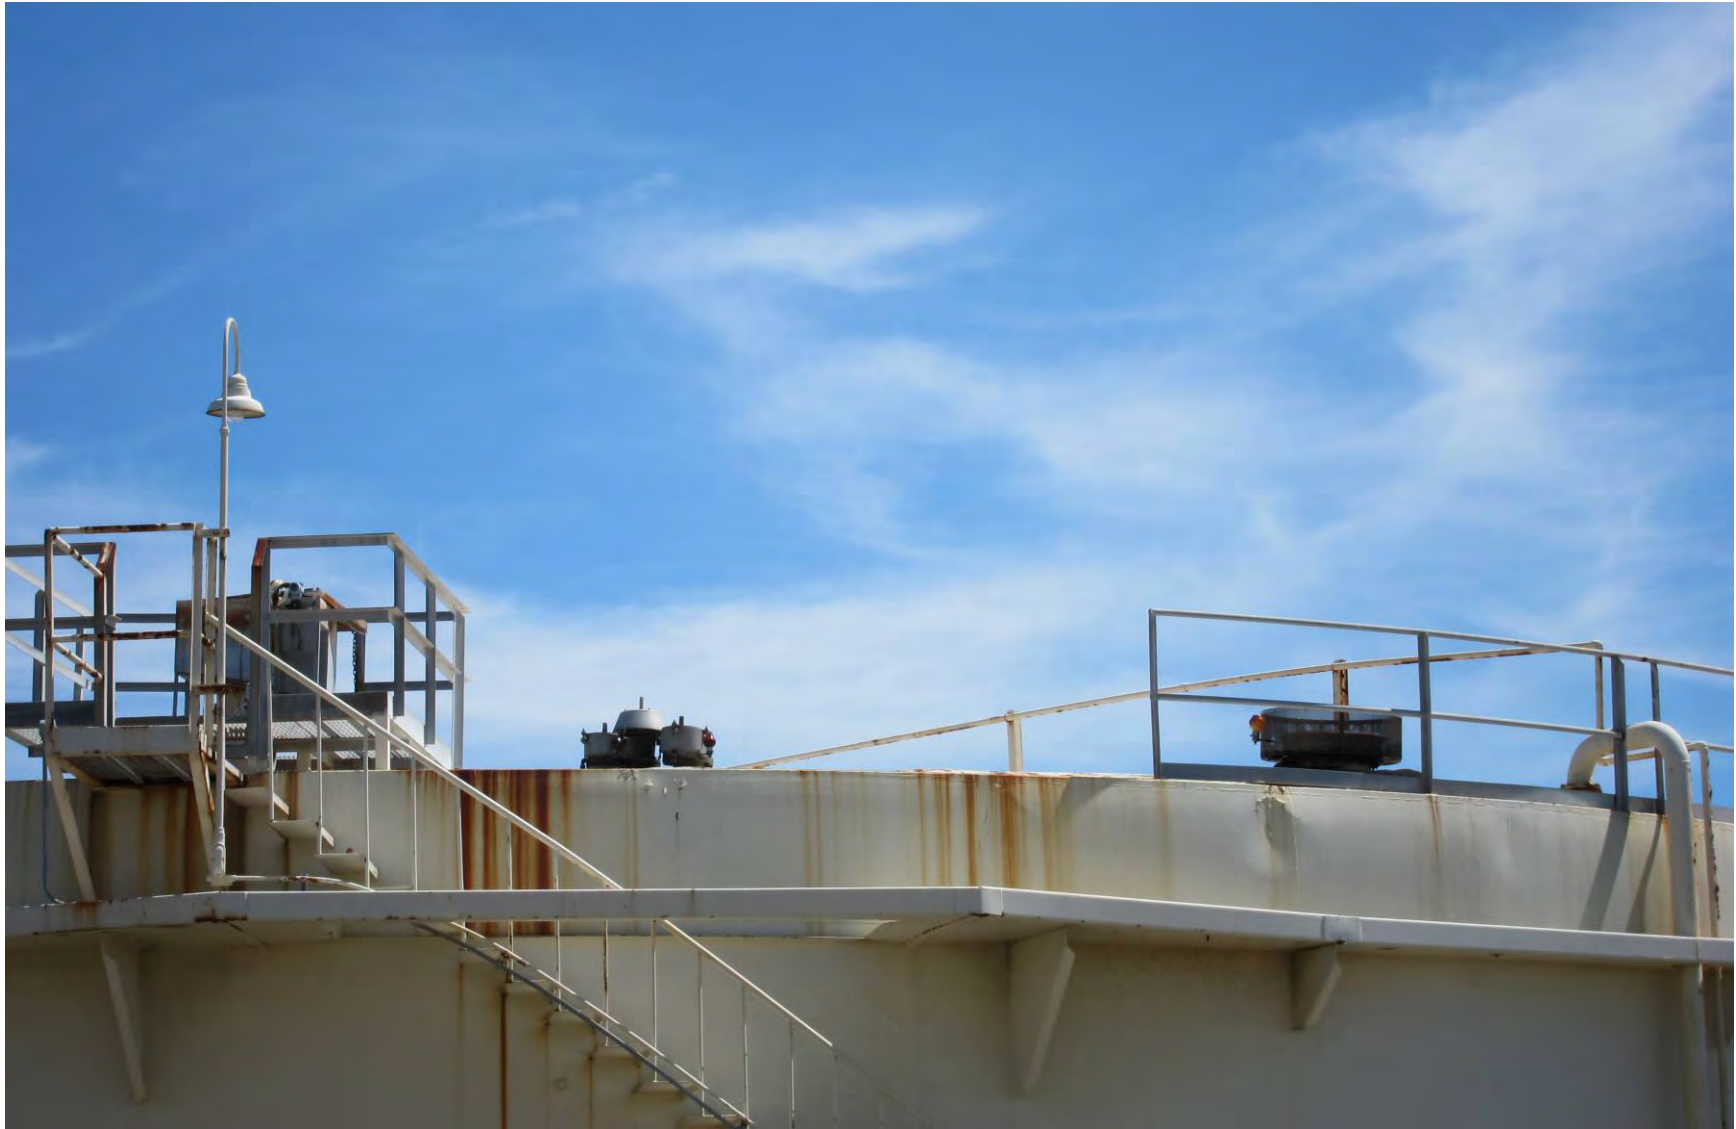
- 1) The Light Naphtha Hydrotreater overhead accumulator (F202) water-hydrocarbon interface level indicator failed to indicate a correct level. This incorrect level indication resulted in the transfer of light hydrocarbons to Tank 294.
- 2) The flashed material generated vapor quantities that exceeded the design capacity of the Tank 294 relief protection system.

The Tank breather valves (PSV-294A & C) are visible to the right of the Gauger's Platform. The 20" Emergency Hatch is behind the railing at the right, near the 6" tank vent line.

Complete a thorough review of the Tank 294 pressure relief system components to verify proper operation of these components. (Root Cause 3a)

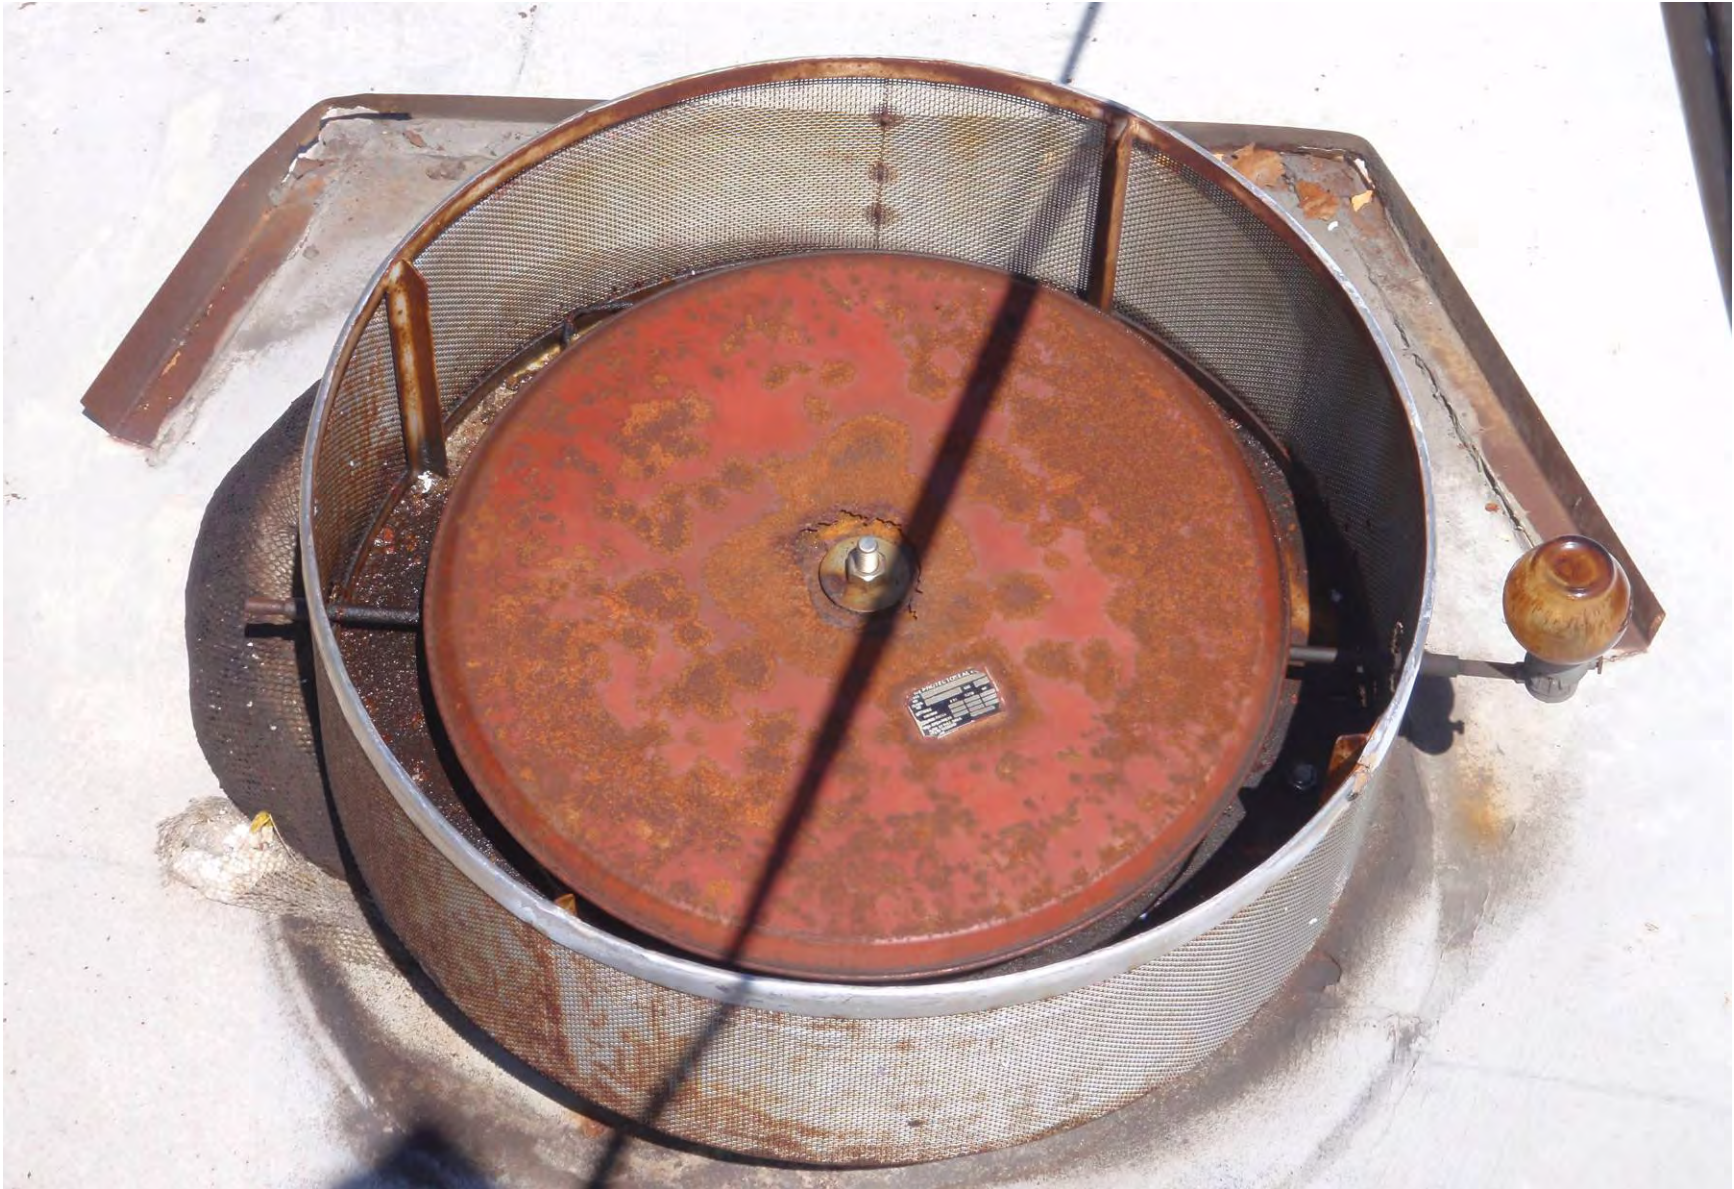
The 20" Emergency Hatch (PSV-294B)

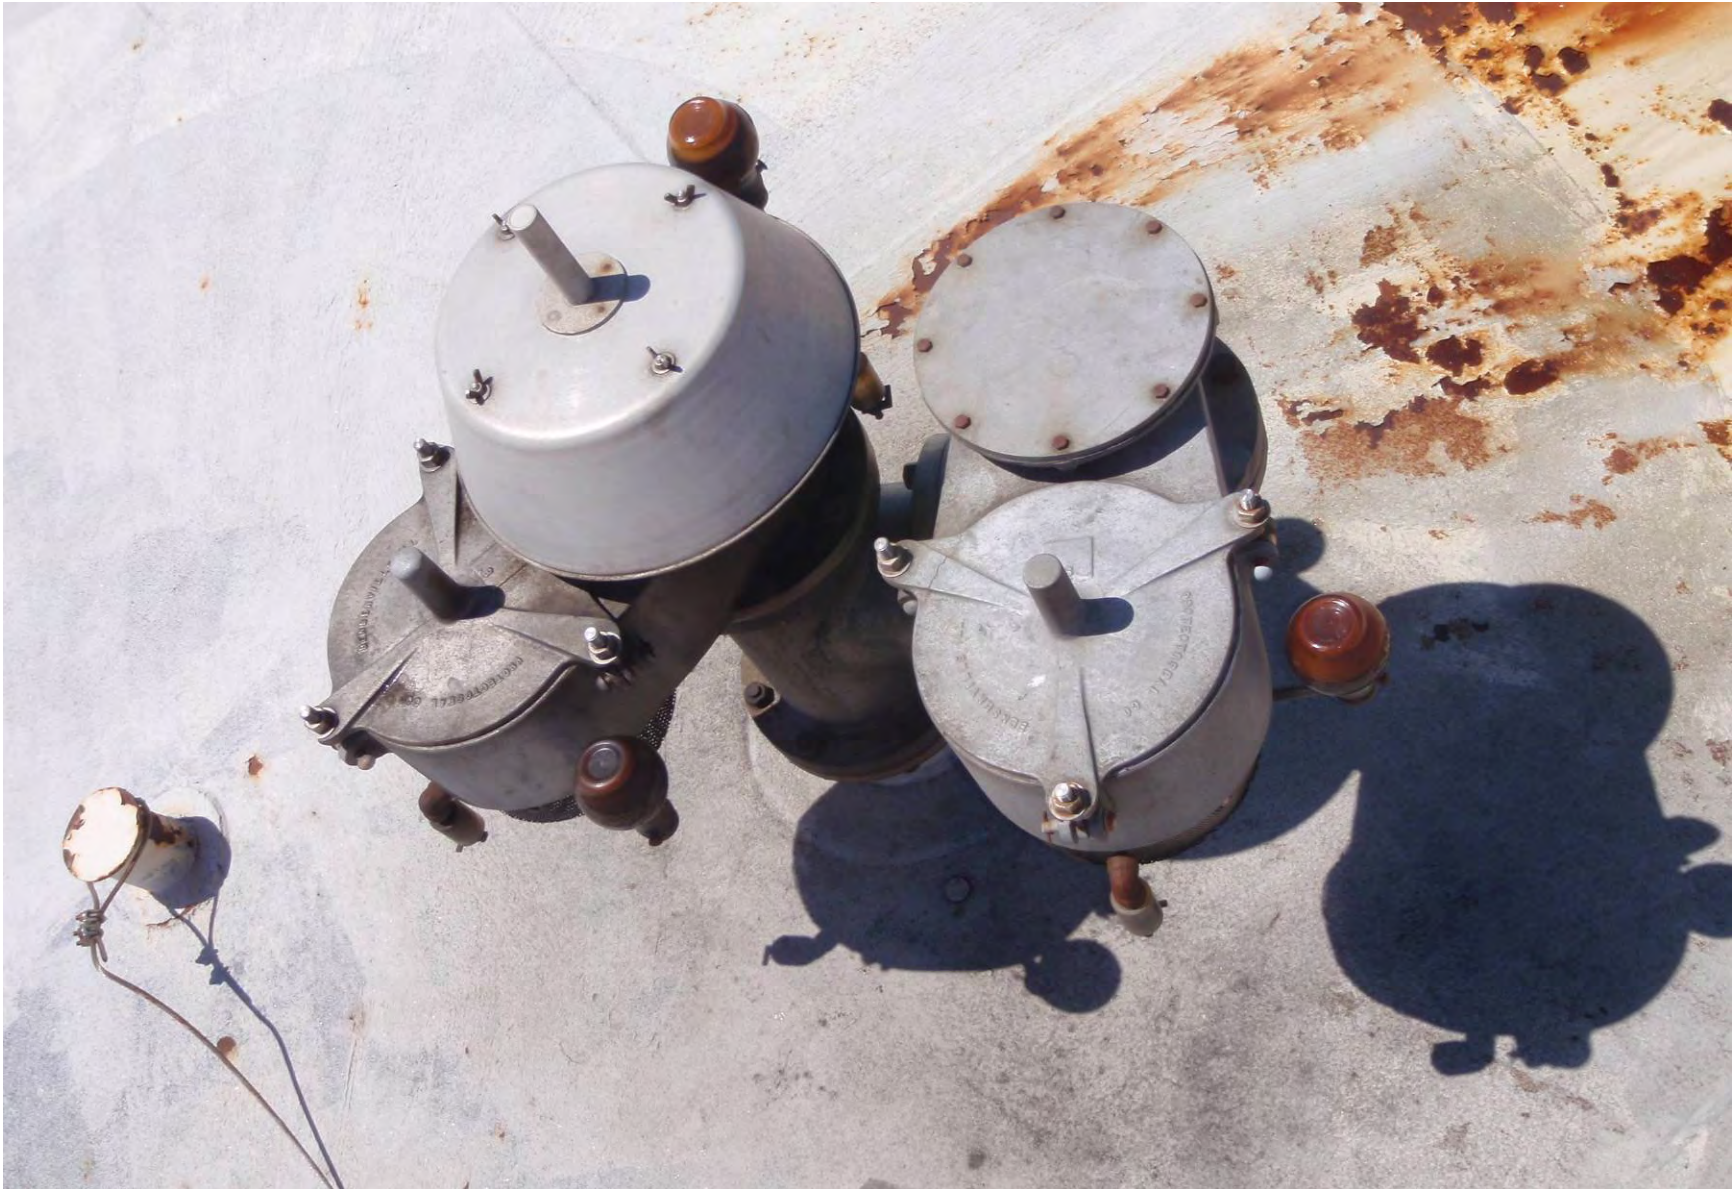
Close-up view of the Tank Breather valves (PSV-294A & C)
