Re: Investigation Report for 07/06/18 Incident

INVESTIGATION REPORT

Shell Oil Products US Martinez, California Refinery Release at LOP (Light Oil Processing) Flare

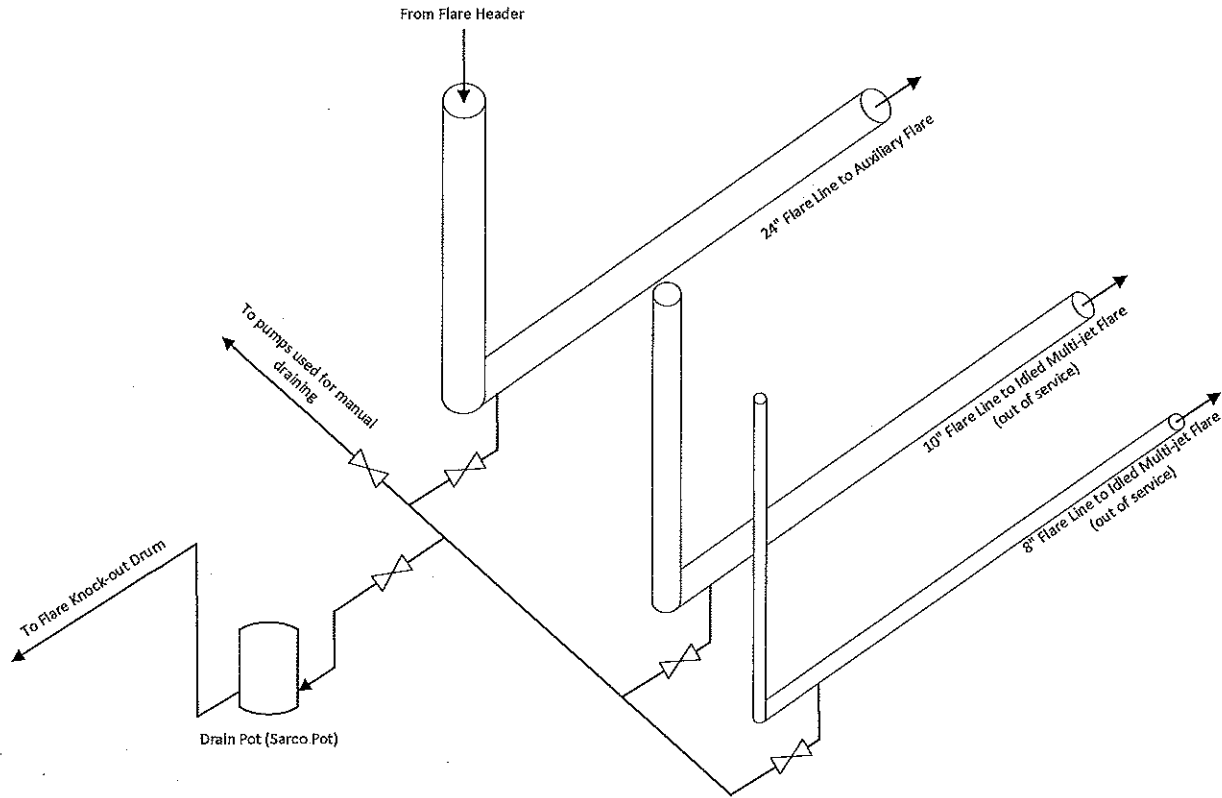
Figure 1 Overview of flare drain system

The elevated flare is used to combust flare gas in a controlled way when unit upsets occur in the refinery. A 24" line is used to transport flare gases from a water seal vessel to the flare tip. This line is sloped to drain liquid back to a collection manifold. The flare header drain pot continually pumps liquid out of the collection manifold. Operations also drains the collection manifold on a weekly basis using one of three pumps which were connected to the manifold. In addition to the 24" line, there are two other lines connected to the collection manifold, an 8" line and a 10" line, which are both blinded upstream and downstream of the collection manifold. See figure 1.

1. An ineffective drain system on the flare line caused significant accumulation of water in the flare line. Accumulation of water in the 24” flare line comes primarily from steam condensing at the flare tip and flowing back into the flare line towards the collection manifold. Water is drained from the collection manifold using the flare header drain pot as well as routine weekly draining by operations using a pump. The investigation discovered that prior to this incident the flare header drain pot was ineffective at removing the water. In

addition, the weekly draining by operations did not successfully remove all the water since operations was only able to determine that the manifold was drained by hearing the drain pump speed up, which indicated that only vapor was being pumped. However, in this investigation it was determined that there was likely another source of vapor in the form of purge nitrogen which was flowing to the 8" & 10" flare lines connected to the same collection manifold. This caused the pump to speed up, leading to a belief that the line was empty and an early shut down of the pump by operations with water remaining in the 24" flare line

2. Evaluate the current functioning of the flare line drain pot (Sarco pot, which is a water drain pot with internals). If the drain pot is not functioning as expected, troubleshoot the issue and ensure the drain pot is repaired.	Specific to only the process/equipment involved in the incident.	1005553	January 6 2019

3. Evaluate the draining of the flare liquid collection system, including both the flare line drain pot (Sarco pot, which is a water drain pot with internals) and the pumps used in routine draining of the collection header. Develop a path forward. If a project is required, develop an engineering request for the mitigation of the risk of water accumulation in the flare line downstream of the seal pot	Specific to only the process/equipment involved in the incident.	1005554	January 6 2019

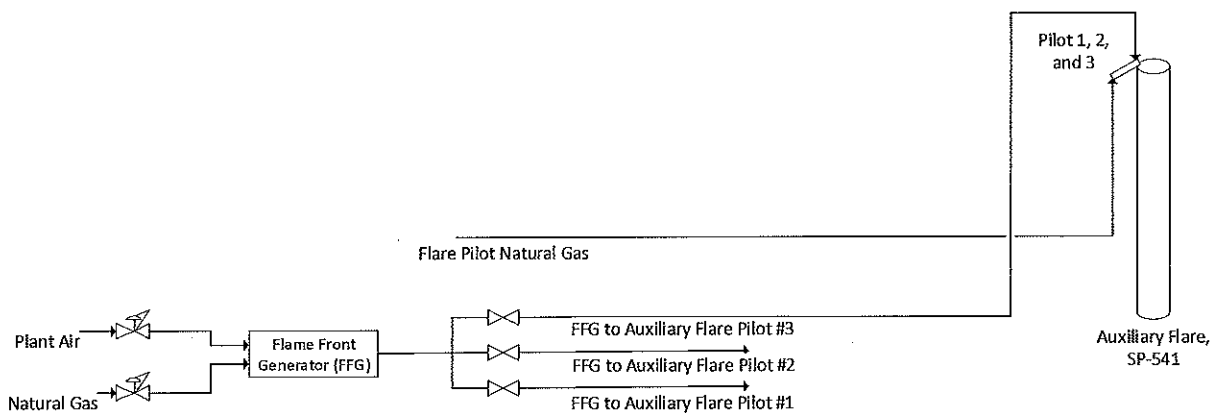
Figure 2 Overview of flame front generator system

Three pilot burners fueled by natural gas are continuously operating at the flare tip to ignite any flare gas sent to the elevated flare. The pilot burners are initially lit/re-lit with a flame front generator lighting system. This system fills a 3/4" pipe with a combustible air/fuel mixture between a remote ignition station and the flare pilot burner. When the pipe is fully primed with a combustible air/fuel mixture the mixture is ignited and the flame travels to the pilot burner to ignite it. See figure 2.

2. Plugging of the flame front generator lines potentially with a combination of corrosion product and water which caused a delay in the relighting of the pilot flames. This caused the pilots to remain unlit during the second flaring event even though operations had started trying to relight the pilots quickly after the loss of pilots.

The corrosion of the flame front generator lines in combination with water entering the flame front generator lines likely created plugging of the lines, however, as this does not impact the integrity of the line, the CCD does not have to be updated. The lines however will be upgraded to stainless steel to prevent the corrosion product plugging the lines, see recommendation #6.

5. Update flare pilot relighting procedure SRU-3390: <ul style="list-style-type: none"> - Add instructions on how and when the flame front generator lines need to be blown out. - Update the time required to purge the lines prior to igniting the mixture. 	Specific to only the process/equipment involved in the incident.	1005556	January 6 2019

6. Evaluate the carbon steel portions of the flame front generator lines, that are not part of ongoing project to upgrade portions of flame front generator lines to stainless steel, and determine whether these also require upgrades to stainless steel.	Specific to only the process/equipment involved in the incident.	1005557	January 6 2019
