Re: 30-day Report for 12/19/16 Incident (Partial Power Outage and Flaring)

## Investigation Report

### Loss of Power to Substations 1203 & 1206

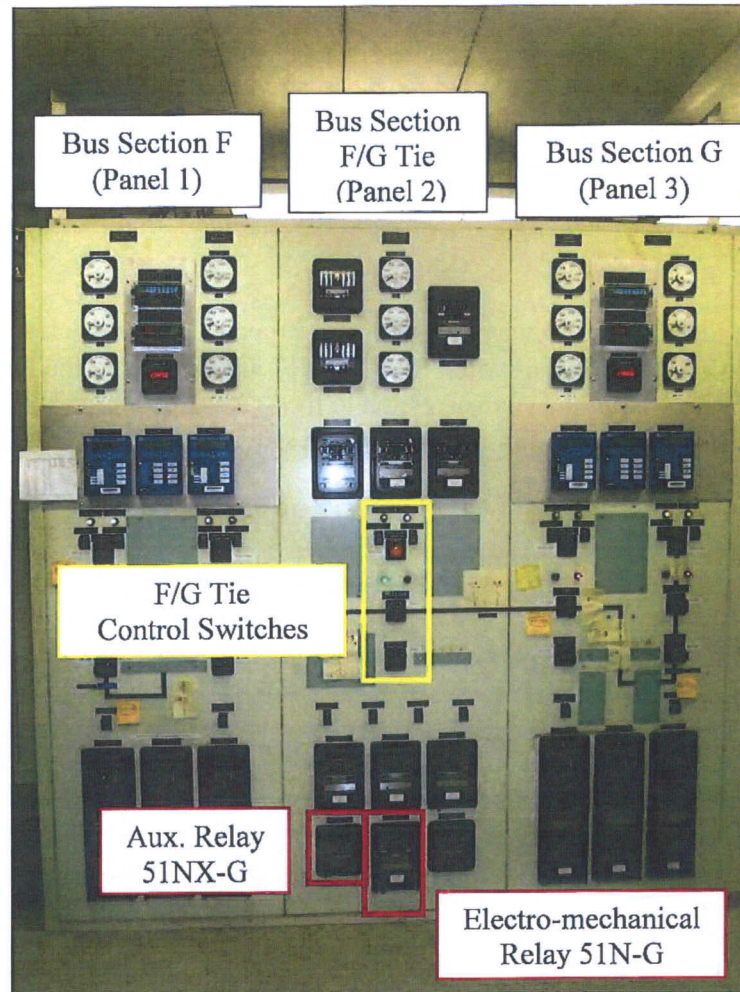
Figure 1: Panels inside Sub 1

The auxiliary relay 51NX-G and the electro-mechanical relay 51N-G are both located on the "12kV Bus Sectionalizing F&G" panel (Panel 2). The E.S. believed that manually closing auxiliary relay 51NX-G was safe from consequence, because the E.S. believed the F/G Tie breaker components located on Panel 2 were isolated from the neighboring panels, Bus Section F, 1600/2 (Panel 1) and Bus Section G, 1700/2 (Panel 3). The labeling of the components on Panel 2 corresponded to the F/G Tie breaker and typically panels were organized by their associated components. The E.S. also had reason to believe that manually closing auxiliary relay 51NX-G on Panel 2 was safe from consequence, because the outdoor F/G Tie breaker was physically isolated from Bus Section G and F when the isolation switches were manually opened in the field. See photo below of Panel 2 inside Sub 1.

Recommendation	Responsible Manager or Individual	Estimated Completion
1. Update Electrical Job Safety Analysis (JSA) template to include verbiage to evaluate the need for additional electrical staff while troubleshooting of breaker controls and protective relaying in main substations (Substations 1, 2, and 3).	Electrical Engineer	8/31/2017
2. Install labels for protective relays on Panel 2 in Sub 1. Labels will identify the corresponding breakers that will trip upon activation of the protective relay.	Electrical Engineer	2/28/2018
3. Install informational label for alarms associated with breaker trips on alarm panel (Panel 6) in Sub 1.	Electrical Engineer	2/28/2018
4. Review incident investigation learnings with all applicable electrical personnel.	Causal Learning Focal Point	6/30/2017

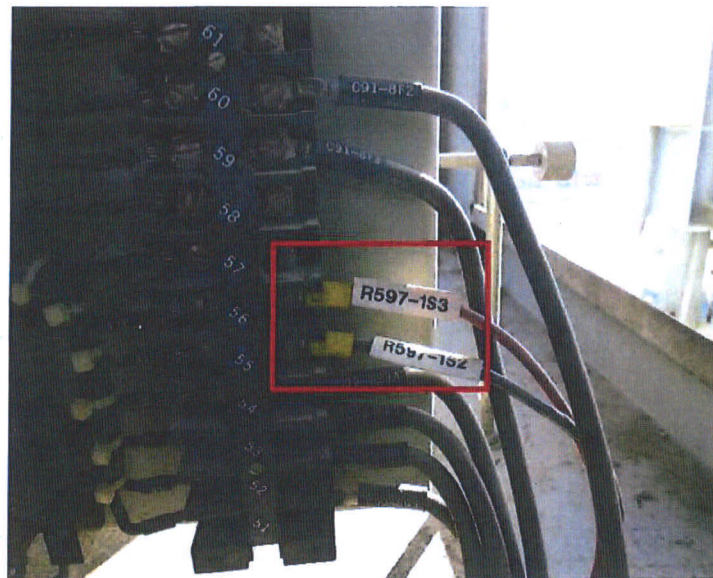
Figure 2 Wires from F/G Tie breaker internals

Lastly, the E.S. had followed out the wires from his initial troubleshooting from the outdoor F/G Tie breaker into Sub 1 control building. These wires were chosen, because the E.S. was aware of the alarm and F/G Tie breaker issue on December 13<sup>th</sup> and was looking for wiring that ran external from the F/G Tie breaker into Panel 2 in Sub 1 control building. The wires were traced out and believed to land on a terminal block at the back of Panel 2, and were subsequently traced to auxiliary relay 51NX-G. The wires that were identified and traced to the back of Panel 2 were distinctive from the other wires, internal and external to the F/G Tie breaker and Panel 2, in that: they were a pair of red and black wires, the wires had similar gauge, wire numbers, wire tags, and yellow wire lugs. See photo below of wires that were traced from the outdoor F/G Tie breaker to the back of Panel 2.

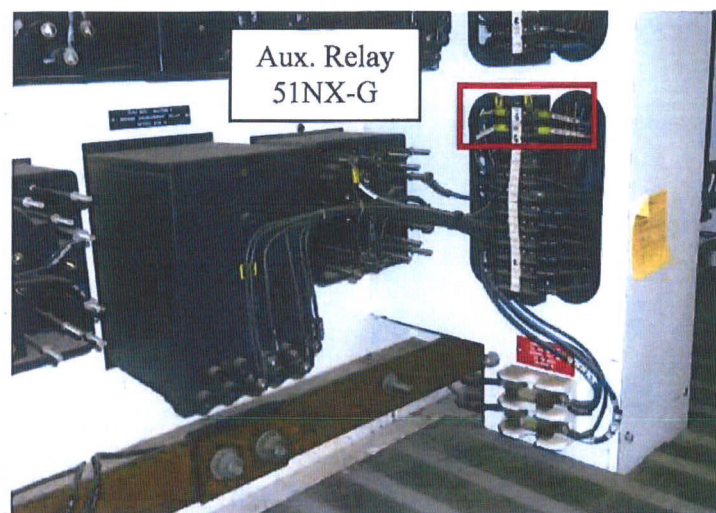
Figure 3 Wires on terminal strip at back of Panel 2

Although isolated physically in the field, auxiliary relay 51NX-G, located on Panel 2, had active wiring to trip Bus Section G's main breaker (1700/2) when manually pushed into the closed position.
