**Independent Investigation of the Catalyst  
Release from Martinez Refining Company on  
November 24-25, 2022**

Report prepared by  
Scott Berger and Associates, LLC

Version 3  
August 22, 2024

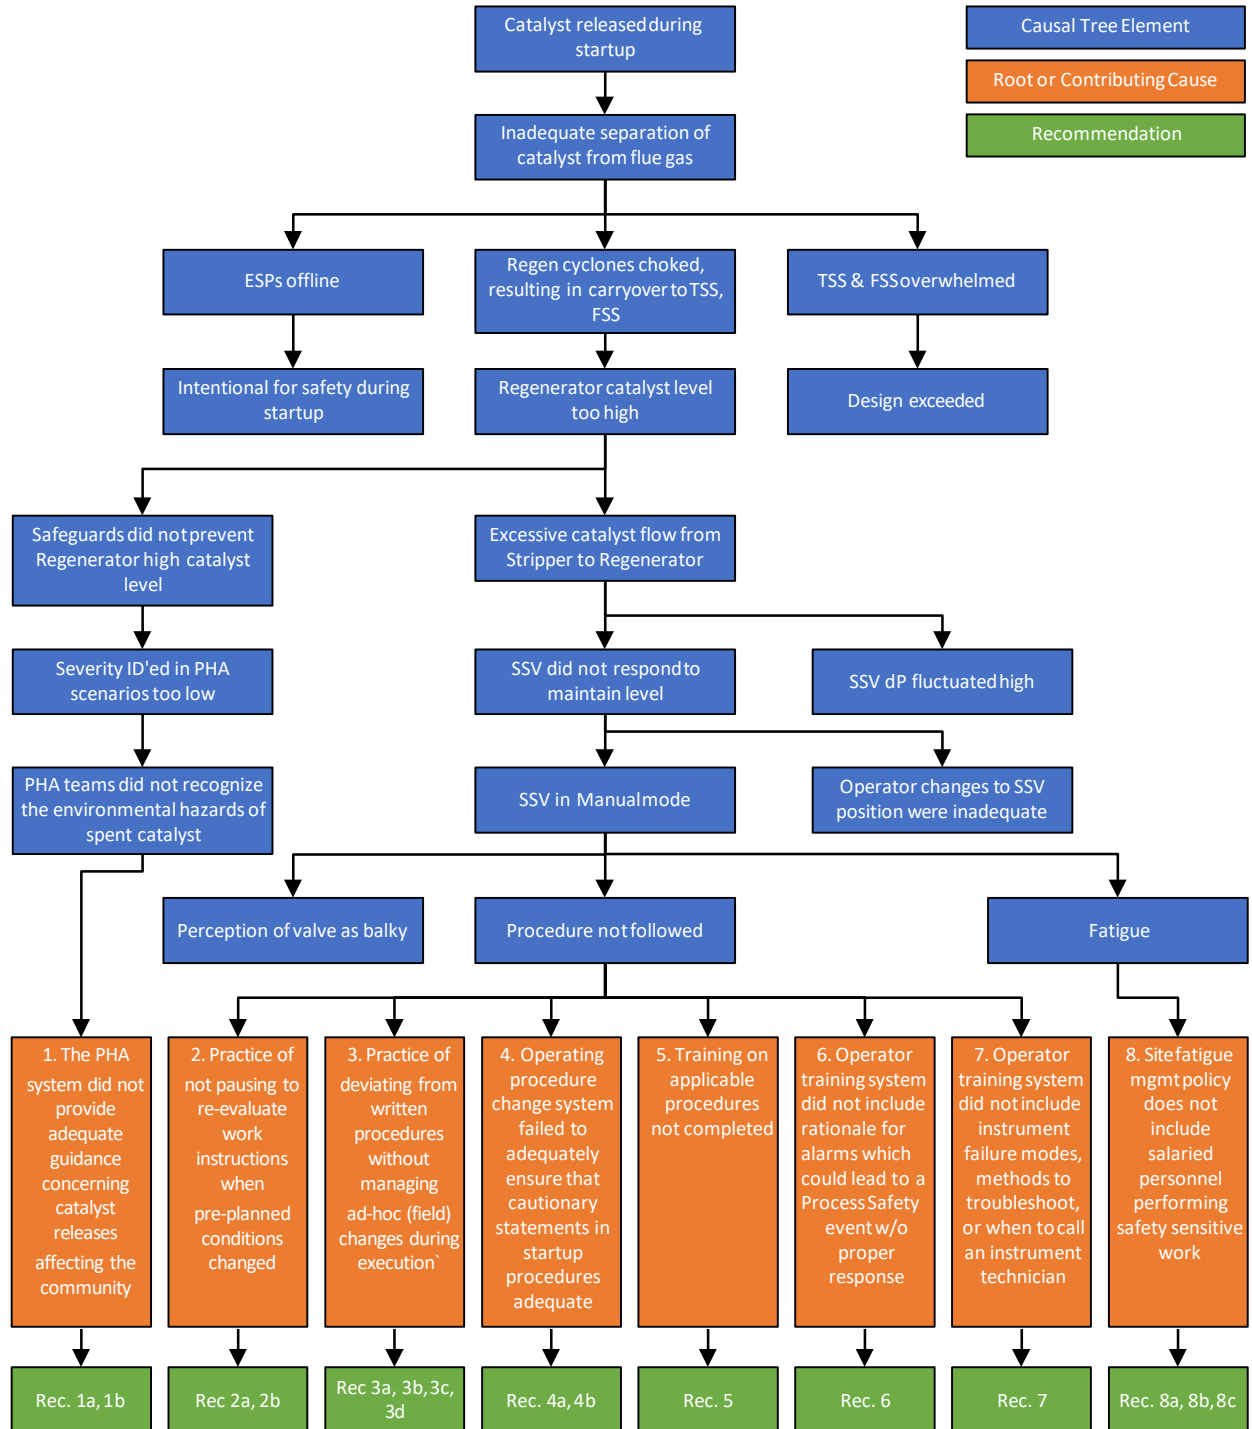
**Figure 2:** Causal tree of November 24-25, 2022, Catalyst Release Incident

The causal tree for this incident is shown below (Figure 2). The key links in the causal chain are described in this section.

**Evaluation of PHA scenarios as “No Action Required”:** Long before this incident, two separate process hazards analyses (PHAs) had been conducted. Each considered causes that could lead to catalyst carryover: the Shell Oil Products CCU PHA in 2018, and the MRC/PBF CO Boilers PHA in 2022. Each PHA team identified scenarios with a potential for a severity two (2) environmental consequence (meaning, minor or no lasting environmental effect, a quantity of release requiring agency notification, or short duration remediation). After evaluating the 2022 catalyst release, CCHHMP determined that the event was a Community Warning System (CWS) Level 2 or higher MCAR due to the need to clean up the released catalyst. The Shell and MRC/PBF systems assign a consequence category of 3 if environmental cleanup is required.

**Stripper SV not in Auto for feed re-introduction:** Operating procedures call for the Stripper SV to be placed in Auto before introduction of feed. The valve was placed in Auto at 04:45 on November 24 while catalyst circulation was being established. However, at 06:29, together with a procedural step to adjust Regenerator and OHA pressures for correct dP's across the SV's, the Stripper SV was placed in Manual. Process data shows that the condition requiring the Stripper SV to be placed in Manual was resolved by 07:30, at which point it should have been placed back in Auto. However, the SSV remained in Manual until 23:25, well after the release began. Instead of operating in Auto per procedure, personnel manually adjusted the SSV position in response to process conditions.

The failure to ensure the SSV was in Auto before introducing feed is a deviation from procedures that had a direct causal link to the incident. Several other deviations from procedures (discussed in section VI.C) served as distractions to personnel and therefore contributed to the incident.
