#771363
IR# 12-06-15-01
Phillips 66
San Francisco Refinery
1380 San Pablo Avenue
Rodeo, CA 94572

Subject: Supplemental Information Report – Tk-294 Over-Pressure Incident

**Rodeo Refinery
Tank 294 Over-Pressure Incident 061512-1
June 25, 2012**

Supplemental Incident Information

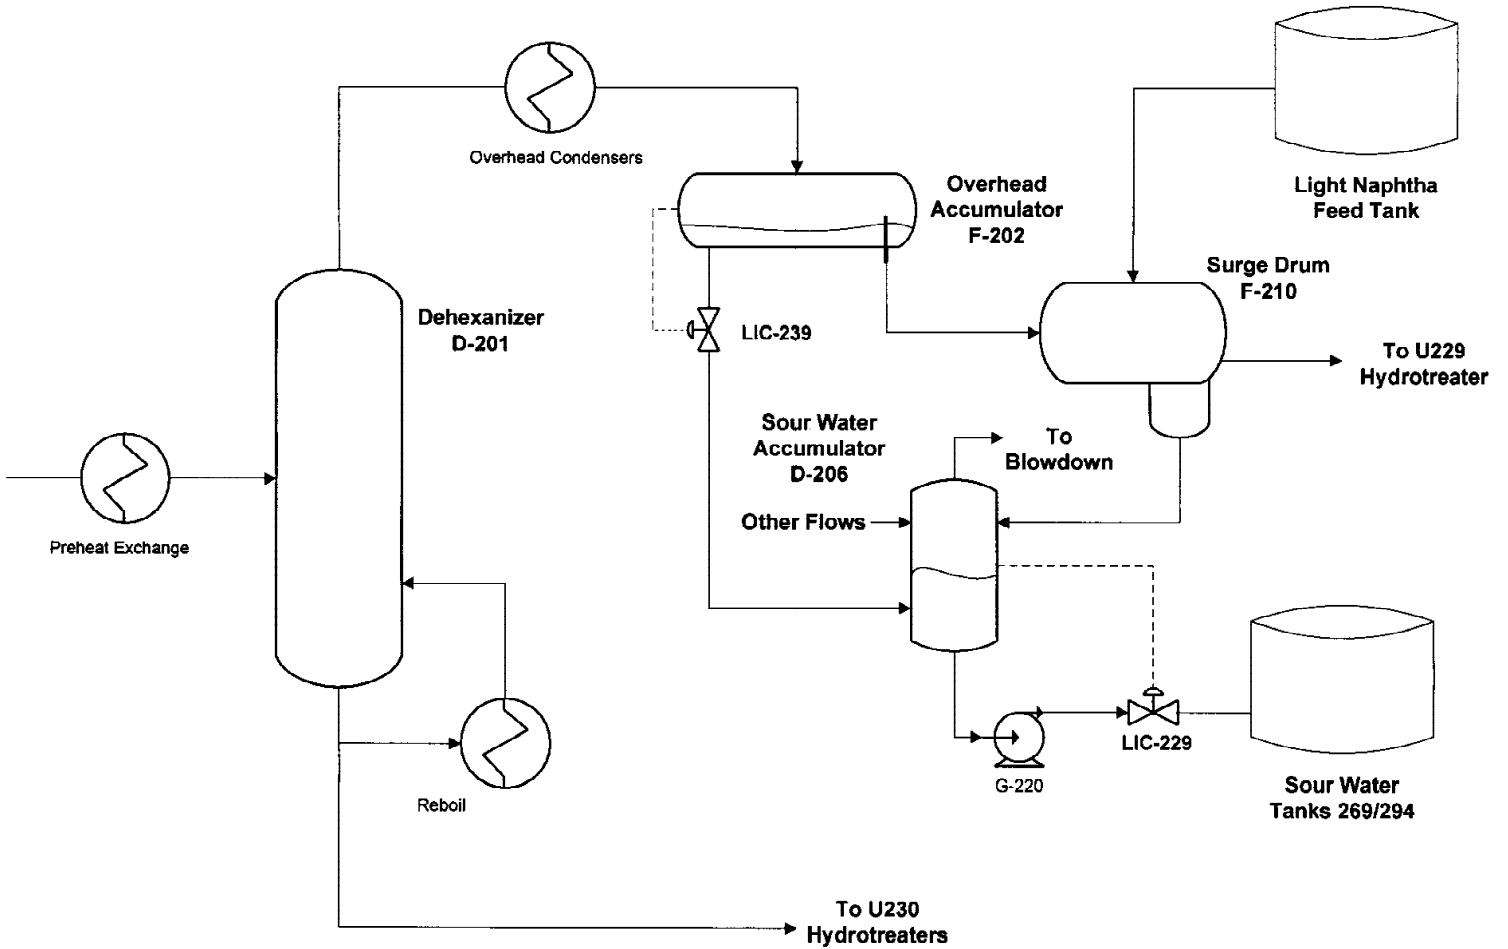
Figure 1
MP-30 Sour Water Collection System
Simplified Process Flow Diagram

At MP-30, vessel F-202 accumulates light gasoline range material from the overhead of the dehexanizer (See Figure 1). This light gasoline range material is the feed stream for Hydrotreating Unit 229 and contains butane at levels of 15 – 25 volume percent. The F-202 accumulator provides separation of the light gasoline from condensed water. An oil-water interface level indicator controller (LIC-239), measures the water level in F-202 and opens the control valve as necessary to maintain the appropriate water level. This control is necessary to prevent water from being carried over into the Unit 229 feed. The water from F-202 flows to Sour Water Accumulator D-206, which is then pumped to Tanks 269 or 294.

The level indicator is a relatively simple measuring device common in industry. Its design uses a float inside a vertical column (pipe) that is connected to vessel F-202. This float sits on the oil-water interface and transmits its relative position in the column via an electric signal. It is believed that the float "hung-up" in the column, causing a false level indication – that would result in control valve LIC-239 remaining open, causing a loss of the oil-water interface that allowed light hydrocarbons to flow to D-206. Consequently, liquid (comprised of a higher volume of light hydrocarbon) was pumped at a rate higher than normal to Tank 269 beginning at approximately 5 a.m. The operator noticed this higher rate approximately 1 hour later. Once the operator became aware of the malfunction, appropriate steps were taken to troubleshoot and correct the operation.

Based on learnings from this incident, Preventative Maintenance (PM) for this type of instrument has been developed that consists of two parts: (1) operational personnel can observe the level at the field sight-glass for comparison to the level that is transmitted to the control room and take an extra step of "blowing-down" the liquid in the level column to remove any debris that may have accumulated, ensuring that an accurate level indication is recovered after this action, and (2) maintenance personnel can check the electrical signal from the device to ensure it matches the observed level.

These two PM programs have been implemented (operator check once/shift and instrument signal check once/week) to prevent the recurrence of this type of malfunction.

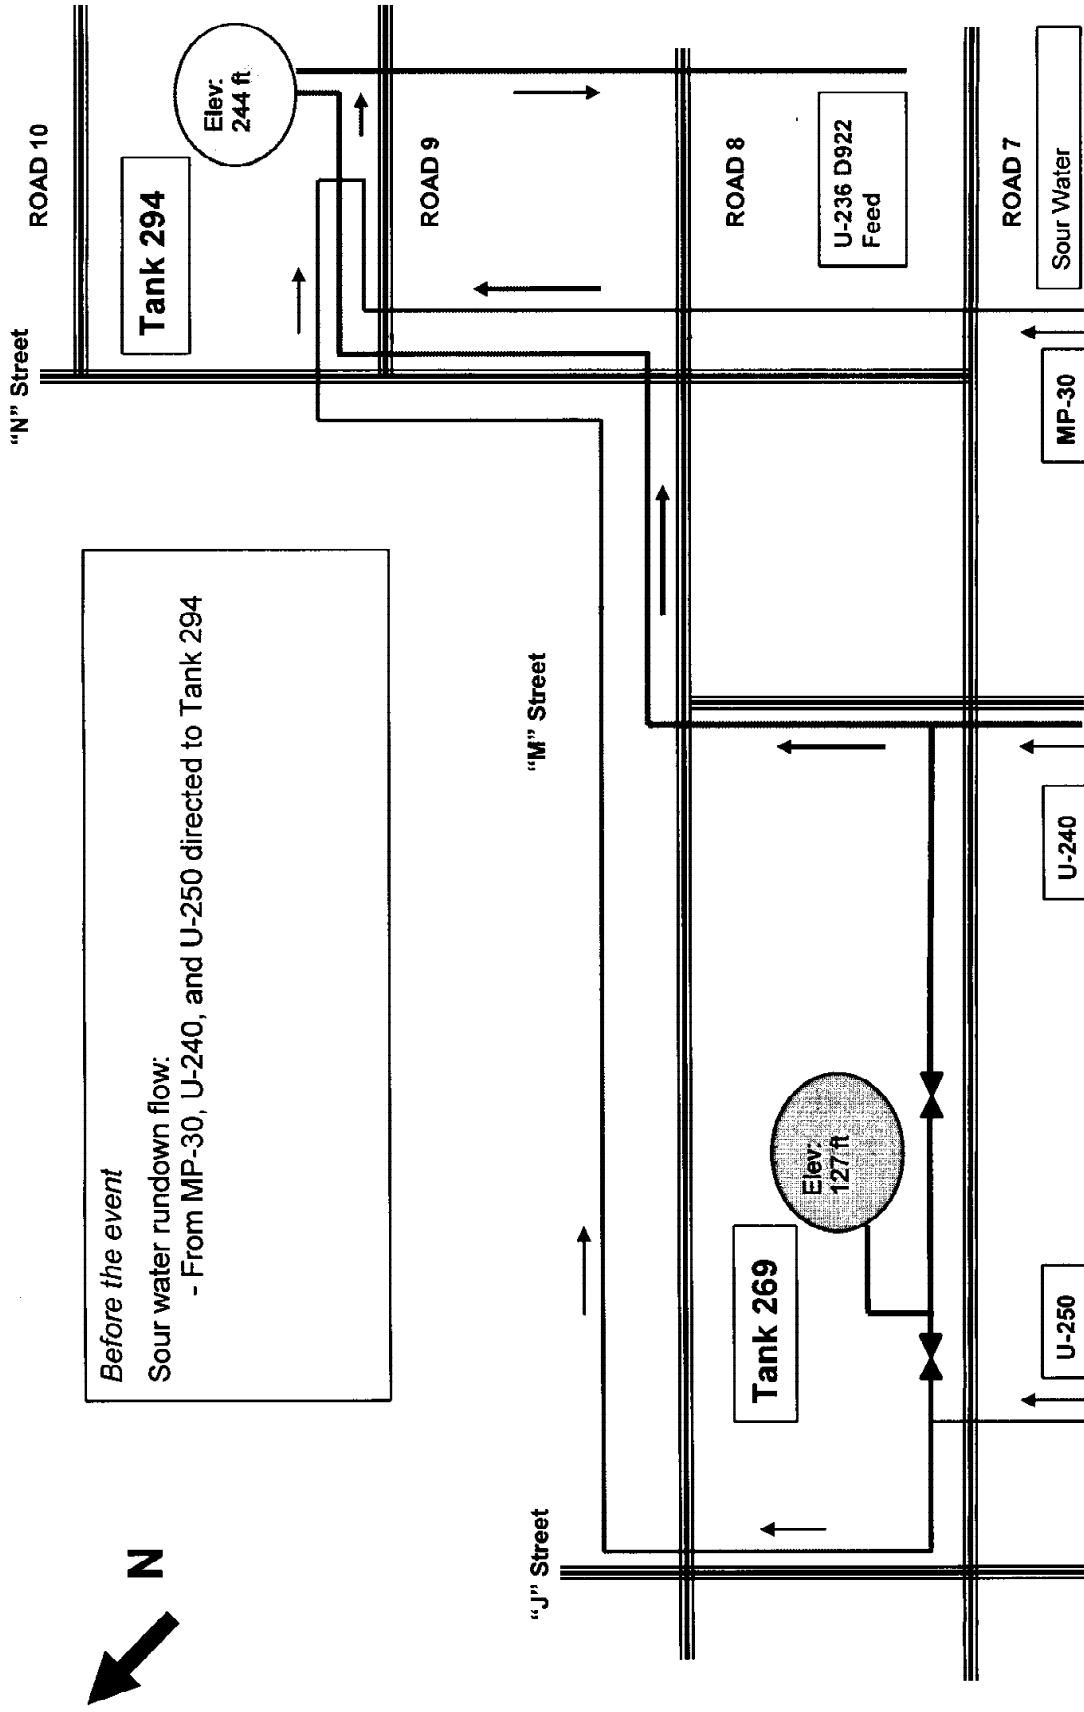
FIGURE 2A. Tank 294 Over-Pressure - Thursday June 14, 2012

Figure 2A. On June 14, before the event, sour water from Units MP-30, U-240 and U-250 were all lined up to Tank 294. Tank 294 was providing feed to the U-236 sour water stripper.

Before the event
Sour water rundown flow:
- From MP-30, U-240, and U-250 directed to Tank 294

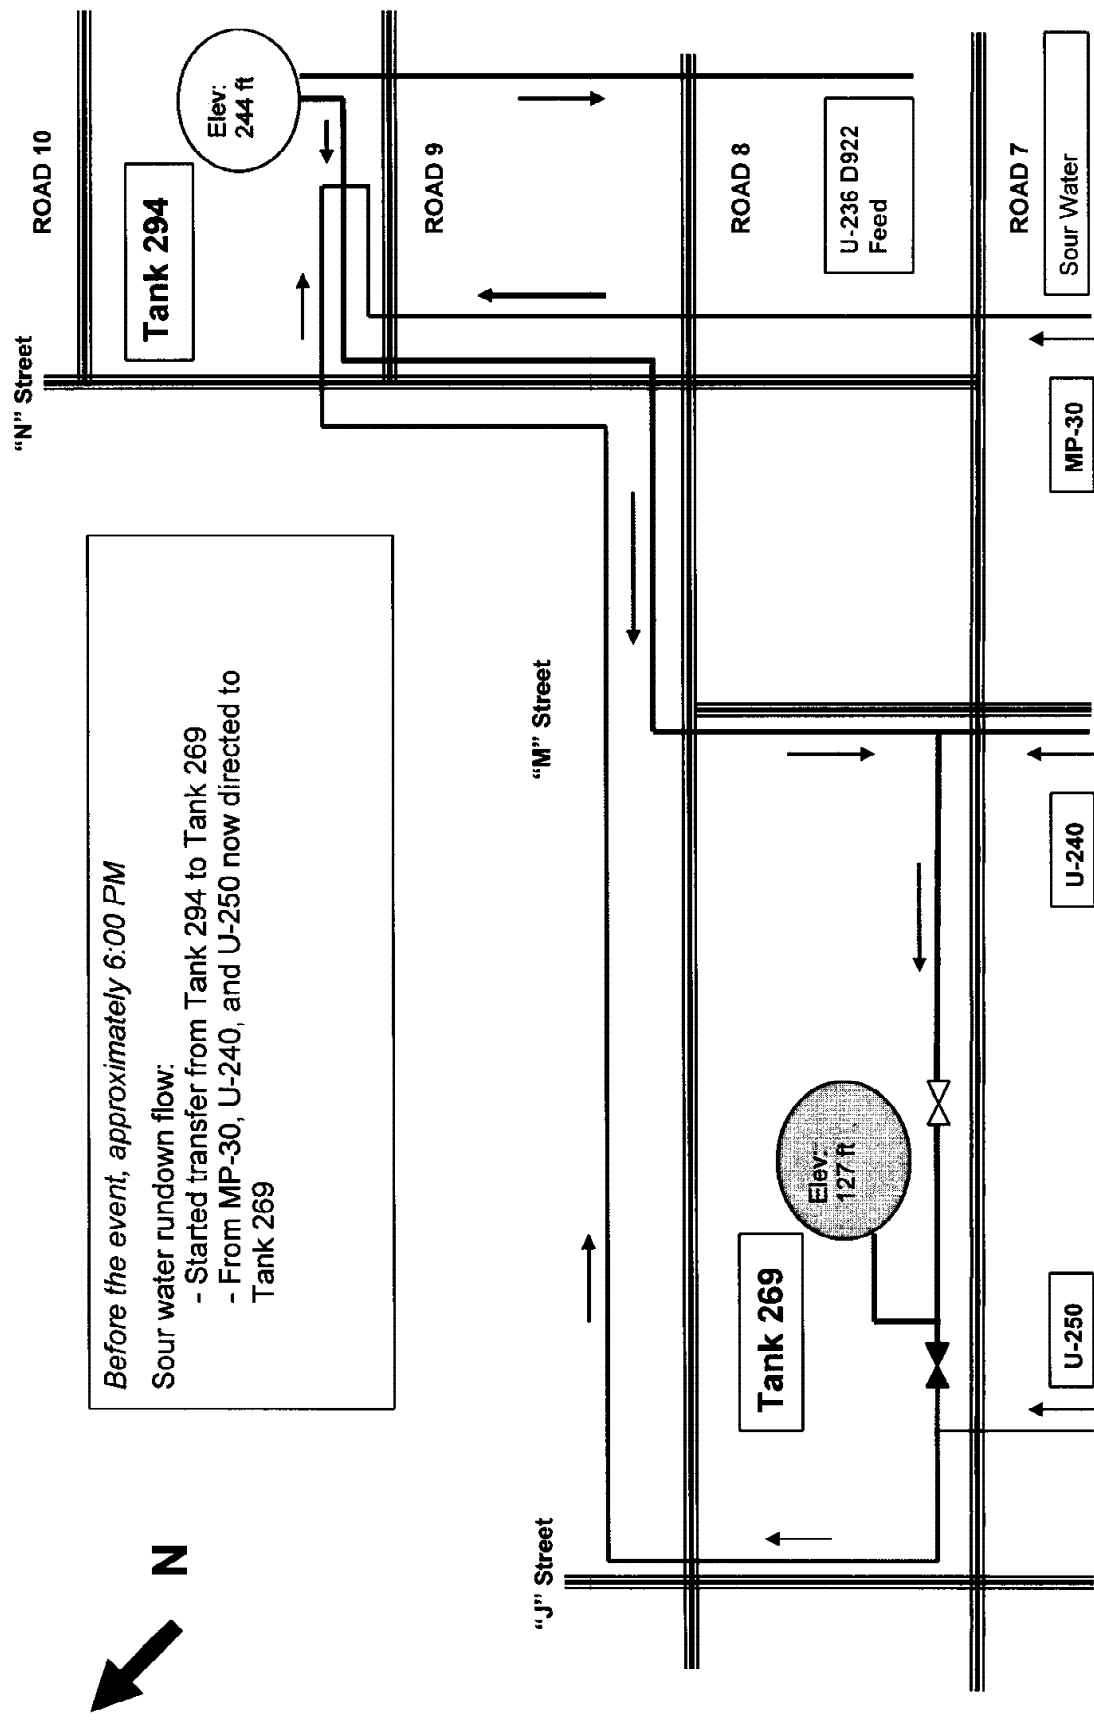
FIGURE 2B. Tank 294 Over-Pressure - Thursday June 14, 2012

Figure 2B. At approximately 6:00 p.m. on June 14, for inventory control, a transfer of water was initiated from Tank 294 to Tank 269. Tank 294 is located at an elevation of 244 ft and Tank 269 is at an elevation of 127 ft. This transfer is conducted by gravity flow by partly opening a valve on the transfer pipeline at Tank 269. This line-up also redirected the flow from Units MP-30, U-240 and U-250 to Tank 269. Tank 294 continued to provide feed to the U-236 sour water stripper.

Before the event, approximately 6:00 PM
 Sour water rundown flow:
 - Started transfer from Tank 294 to Tank 269
 - From MP-30, U-240, and U-250 now directed to Tank 269

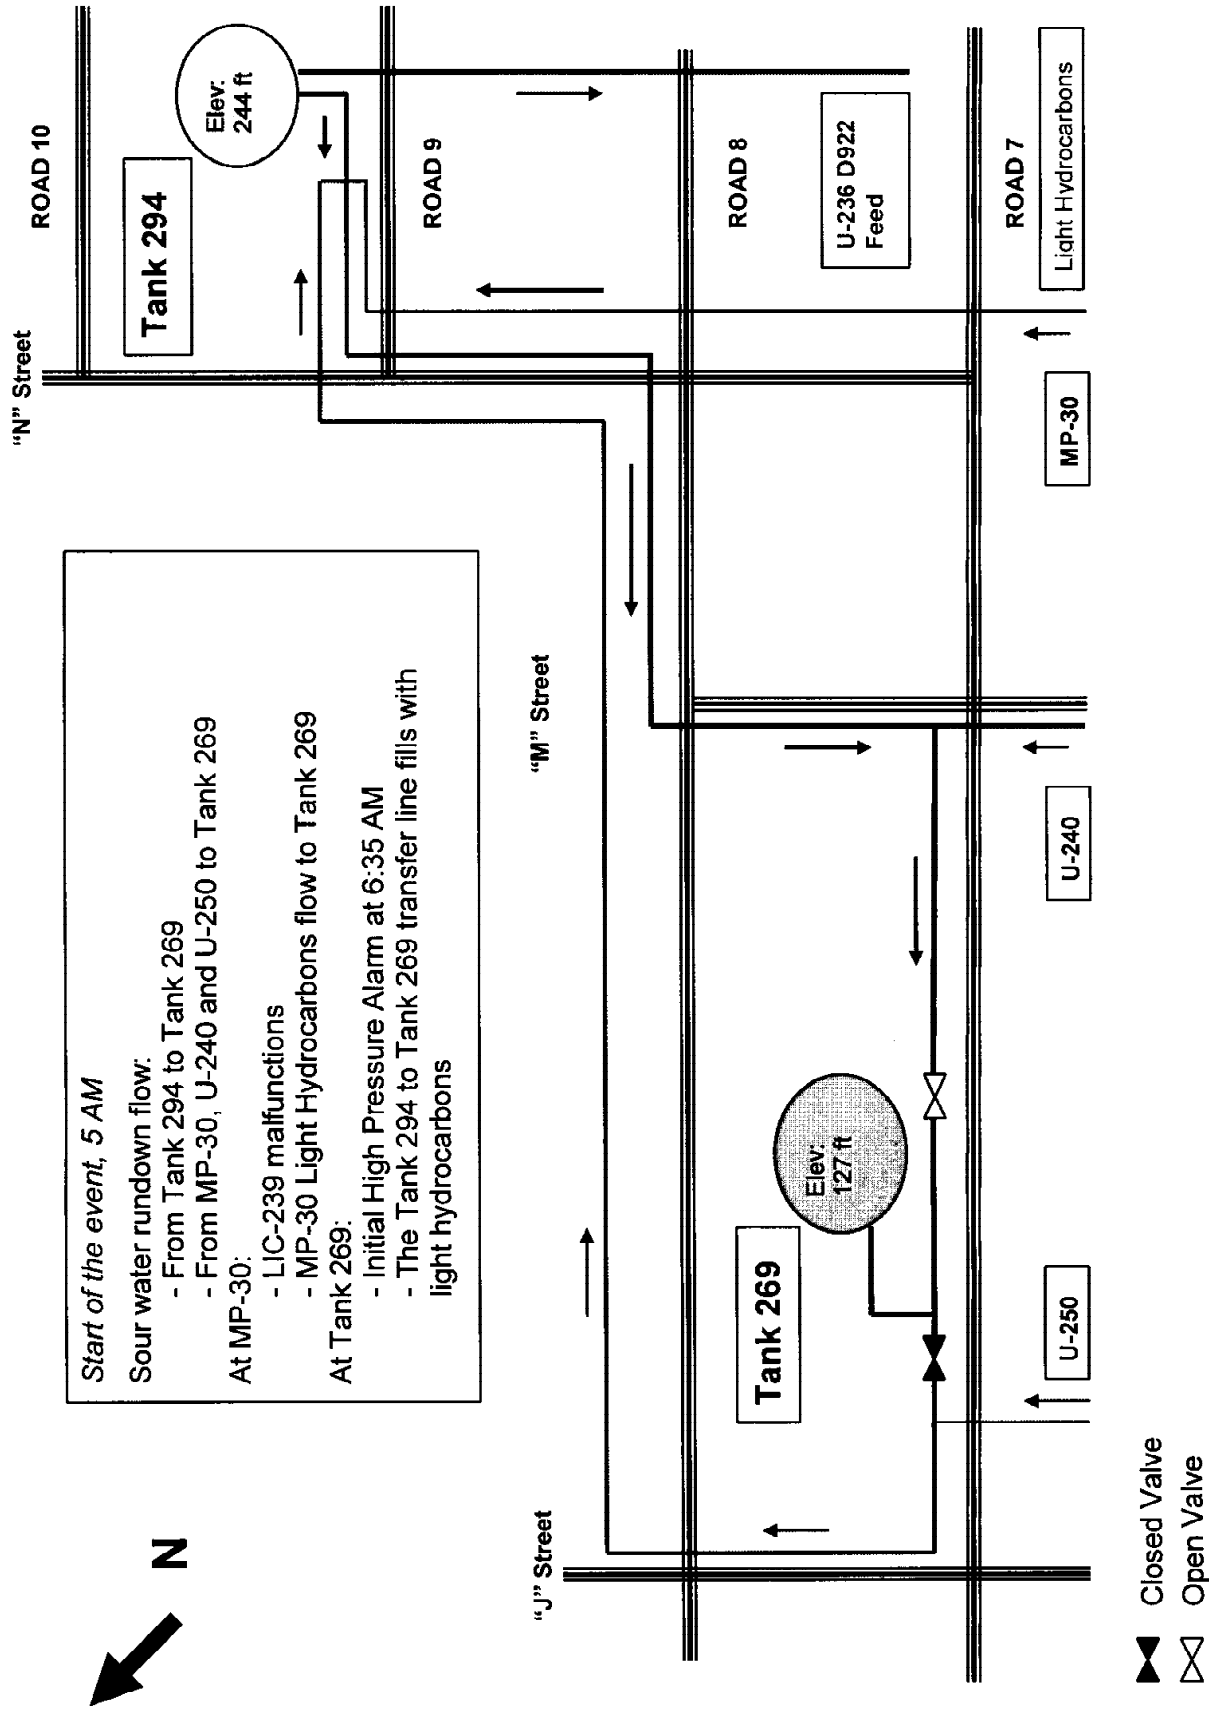
FIGURE 2C. Tank 294 Over-Pressure - Friday June 15, 2012

Figure 2C. At approximately 5 a.m. on June 15, level indicator controller LIC-239 at MP-30 malfunctioned, resulting in light hydrocarbons being pumped to Tank 269. At 6:35 a.m., Tank 269 experienced an initial high pressure alarm. The transfer pipeline between Tank 294 and 269 becomes filled with light hydrocarbons that are vaporizing.

Start of the event, 5 AM
Sour water rundown flow:
- From Tank 294 to Tank 269
- From MP-30, U-240 and U-250 to Tank 269
At MP-30:
- LIC-239 malfunctions
- MP-30 Light Hydrocarbons flow to Tank 269
At Tank 269:
- Initial High Pressure Alarm at 6:35 AM
- The Tank 294 to Tank 269 transfer line fills with light hydrocarbons

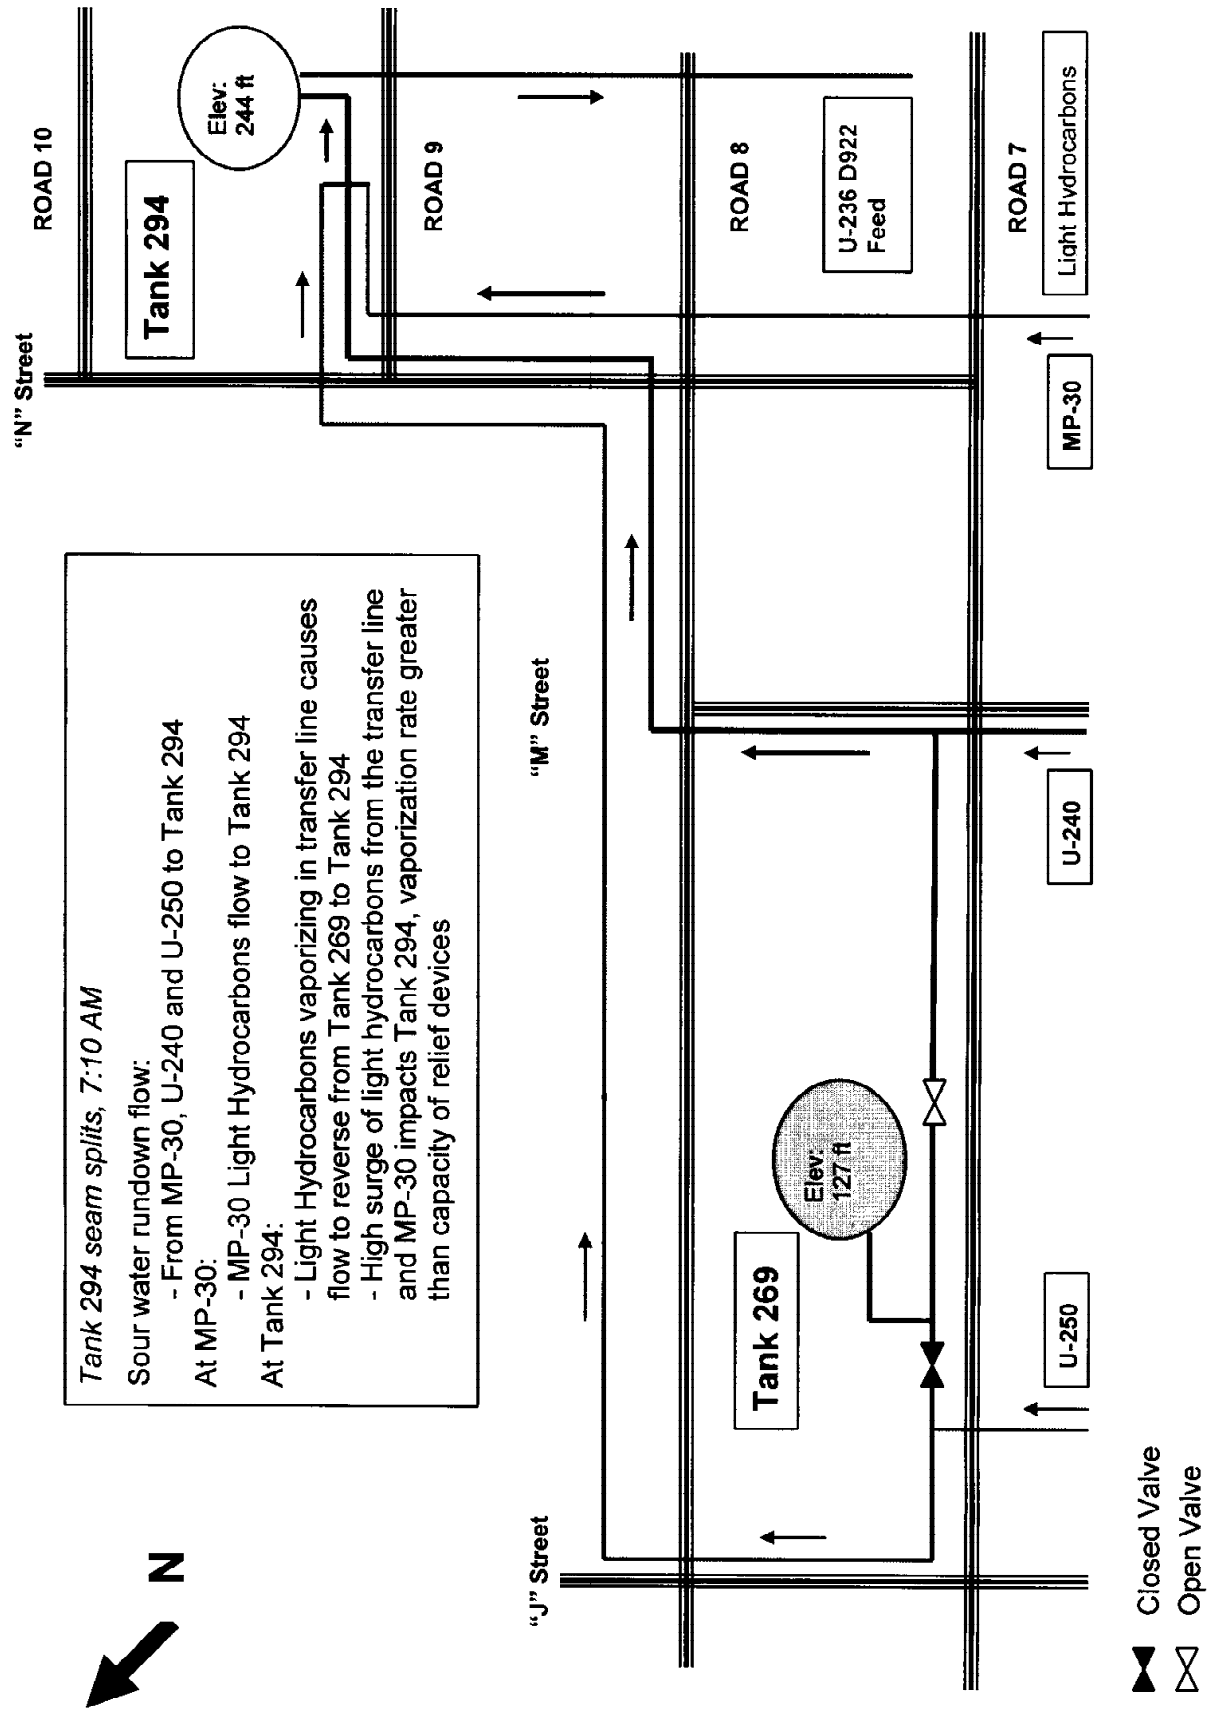
FIGURE 2D. Tank 294 Over-Pressure - Friday June 15, 2012

The key event leading to the Tank 294 overpressure is the flow reversal from the Tank 269 transfer line, causing a high rate of light hydrocarbons to discharge to the tank. Rapid vaporization of the butane resulted in a pressure surge that overwhelmed the capacity of the relief devices. Engineering calculations lead us to conclude that the rate of hydrocarbon flow from MP-30, by itself, would not generate a hydrocarbon vaporization rate high enough to cause a tank rupture. However, the combined flow from these two streams did create such a condition. Refer to Figures 2A – 2D.

Figure 2D. At approximately 7:10 a.m., the vaporizing hydrocarbon in the transfer pipeline caused the flow to reverse to Tank 294. The surge flow of light hydrocarbons in the transfer pipeline combined with the light hydrocarbons from MP-30 result in a high rate of vaporization in Tank 294, overwhelming the capacity of the Tank 294 relief devices.

Tank 294 seam splits, 7:10 AM
 Sour water rundown flow:
 - From MP-30, U-240 and U-250 to Tank 294
 At MP-30:
 - MP-30 Light Hydrocarbons flow to Tank 294
 At Tank 294:
 - Light Hydrocarbons vaporizing in transfer line causes flow to reverse from Tank 269 to Tank 294
 - High surge of light hydrocarbons from the transfer line and MP-30 impacts Tank 294, vaporization rate greater than capacity of relief devices
