April 27, 2015

30 Day Report for the Level II Incident at The Dow Chemical Company facility in Pittsburg, CA

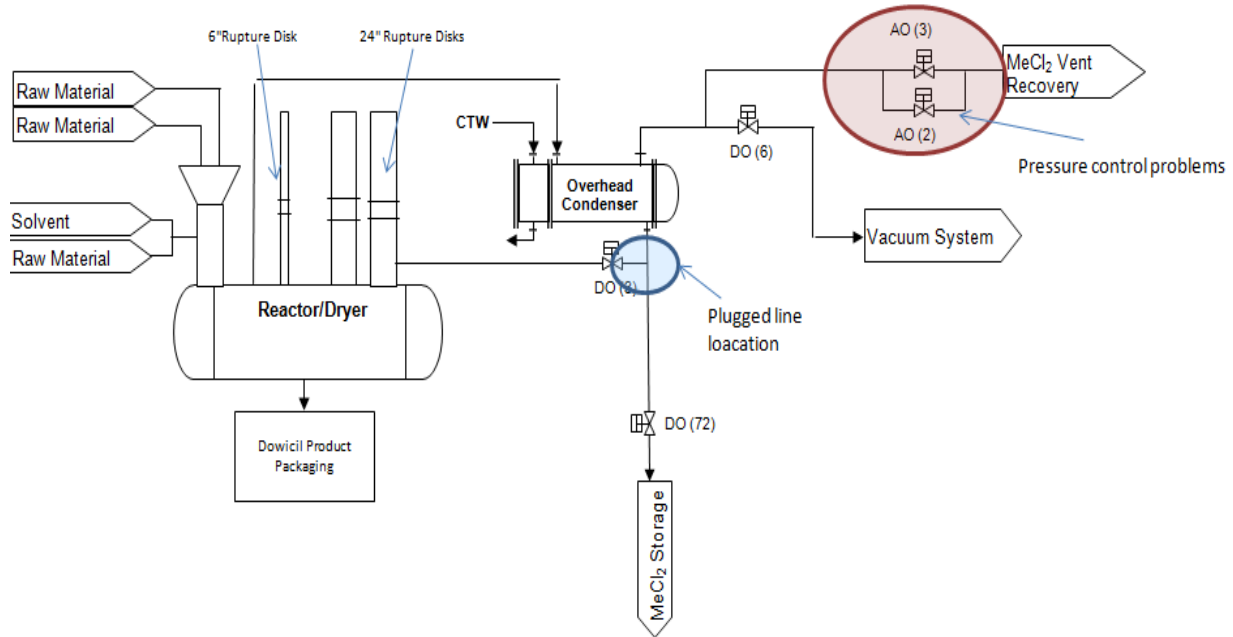
The cause for the decomposition reaction is that both: 1) the Dowicil product dried quicker than expected and 2) the dried product was held at an elevated temperature meant for product that is not dried. The reason the product dried sooner than expected because a plug in the reflux line prevented the normal refluxing of solvent (methylene chloride) back to the reactor / dryer. Due to the plugged line, the solvent was not recycled back to the reactor/dryer. With the loss of solvent recycle, the product dried sooner than anticipated. There were also pressure control problems associated with the high solvent flow to the vent recovery system. This prevented the process from terminating the solvent

boil step and moving to the drying step where a vacuum is used, instead of heat to remove the last part of the solvent from the Dowicil product.

Reflux line plugged, this plugging went unresolved and the consequence of loss of more solvent than usual in the react step was not understood.

Manual control was taken on the vent line pressure control loop. There was less than adequate understanding on the impact manual control has on the process step termination.

Implement a means to prevent plugging or add instrumentation to identify a no flow condition in the H-210/D-201 seal leg. MOC and train operations on the changes. Estimated completion date is June 15, 2015.

Develop a process control strategy document (PCSD) for the vent header pressure control associated with the Post React Step and the Solvent Pool Boil step. Estimated completion date is June 15, 2015.

Implement process control code consistent with the process control strategy document (PCSD) for the vent header pressure control associated with the Post React Step and the Solvent Pool Boil step. Estimated completion date is June 15, 2015.

Update all associated operating discipline for the vent header pressure control associated with the Post React Step and the Solvent Pool Boil Step. Estimated completion date is June 15, 2015.
