**ATTACHMENT C
30-DAY FOLLOW-UP NOTIFICATION REPORT FORM
CONTRA COSTA HEALTH SERVICES**

INCIDENT DATE: August 2, 2015
INCIDENT TIME: 15:05
FACILITY: Phillips 66 Rodeo Refinery

**Rodeo Refinery
Coker Antifoam Fire 080215-1
August 2, 2015**

Incident Investigation Report

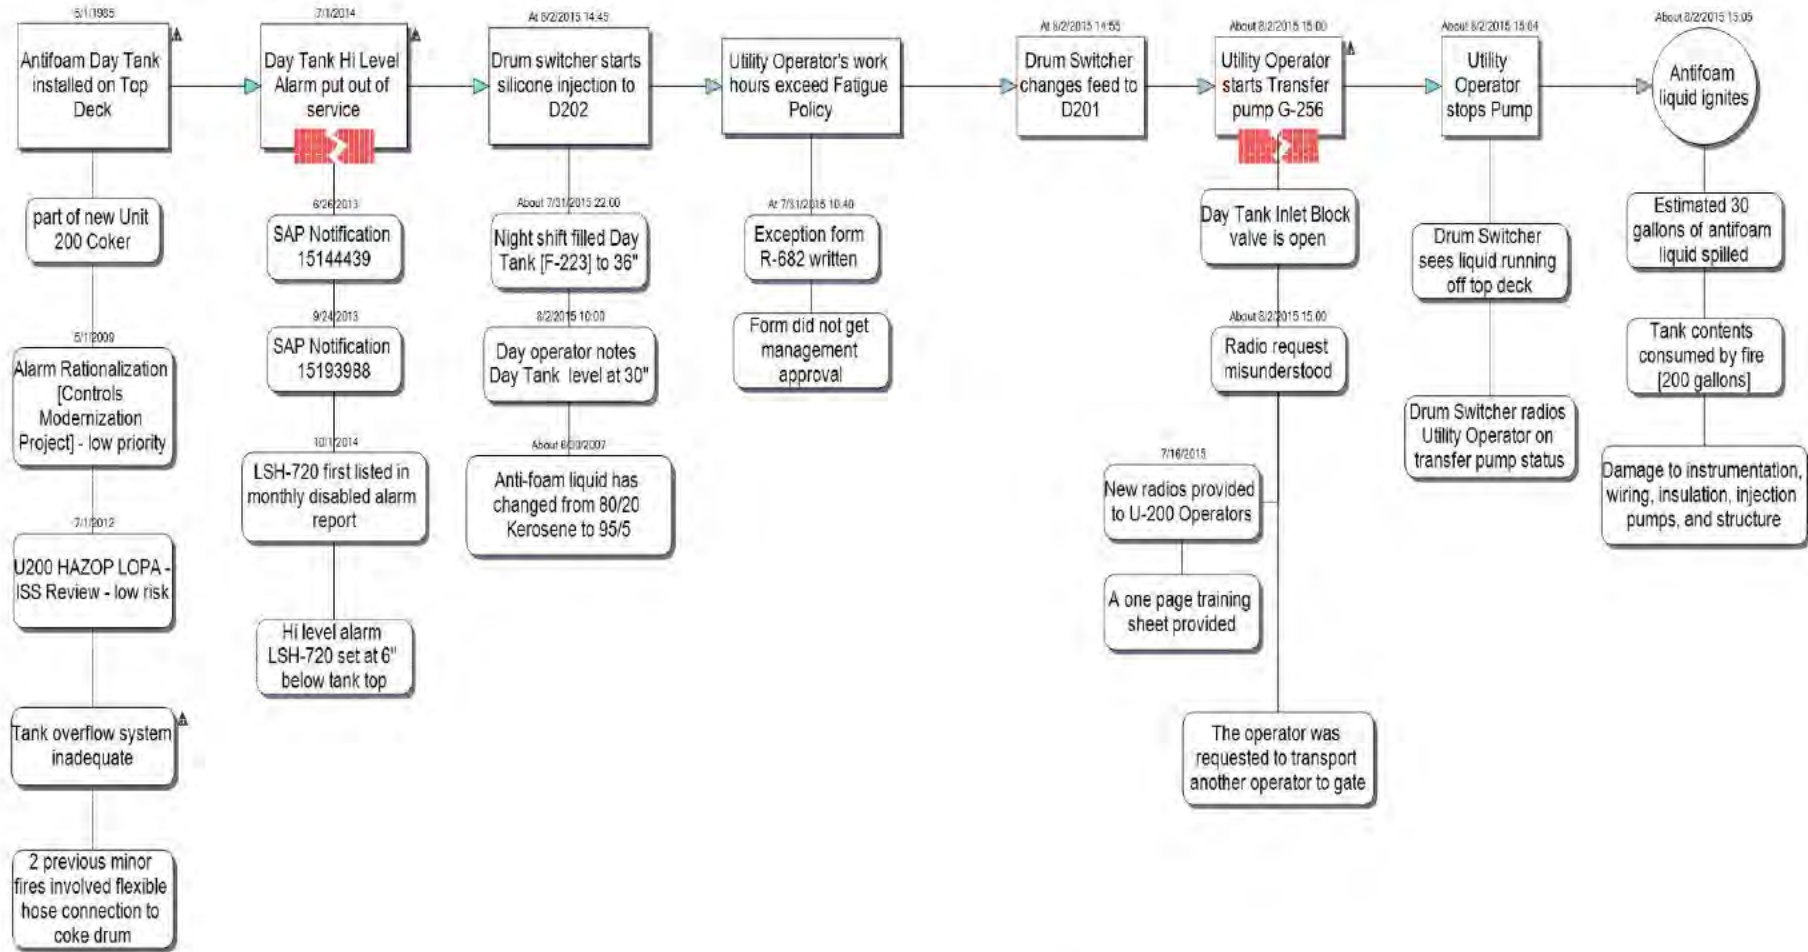
ATTACHMENT 1: TapRoot® Root Cause Analysis Summary

1. The latent (or root causes, RC) of the event are listed below by causal factor (CF).

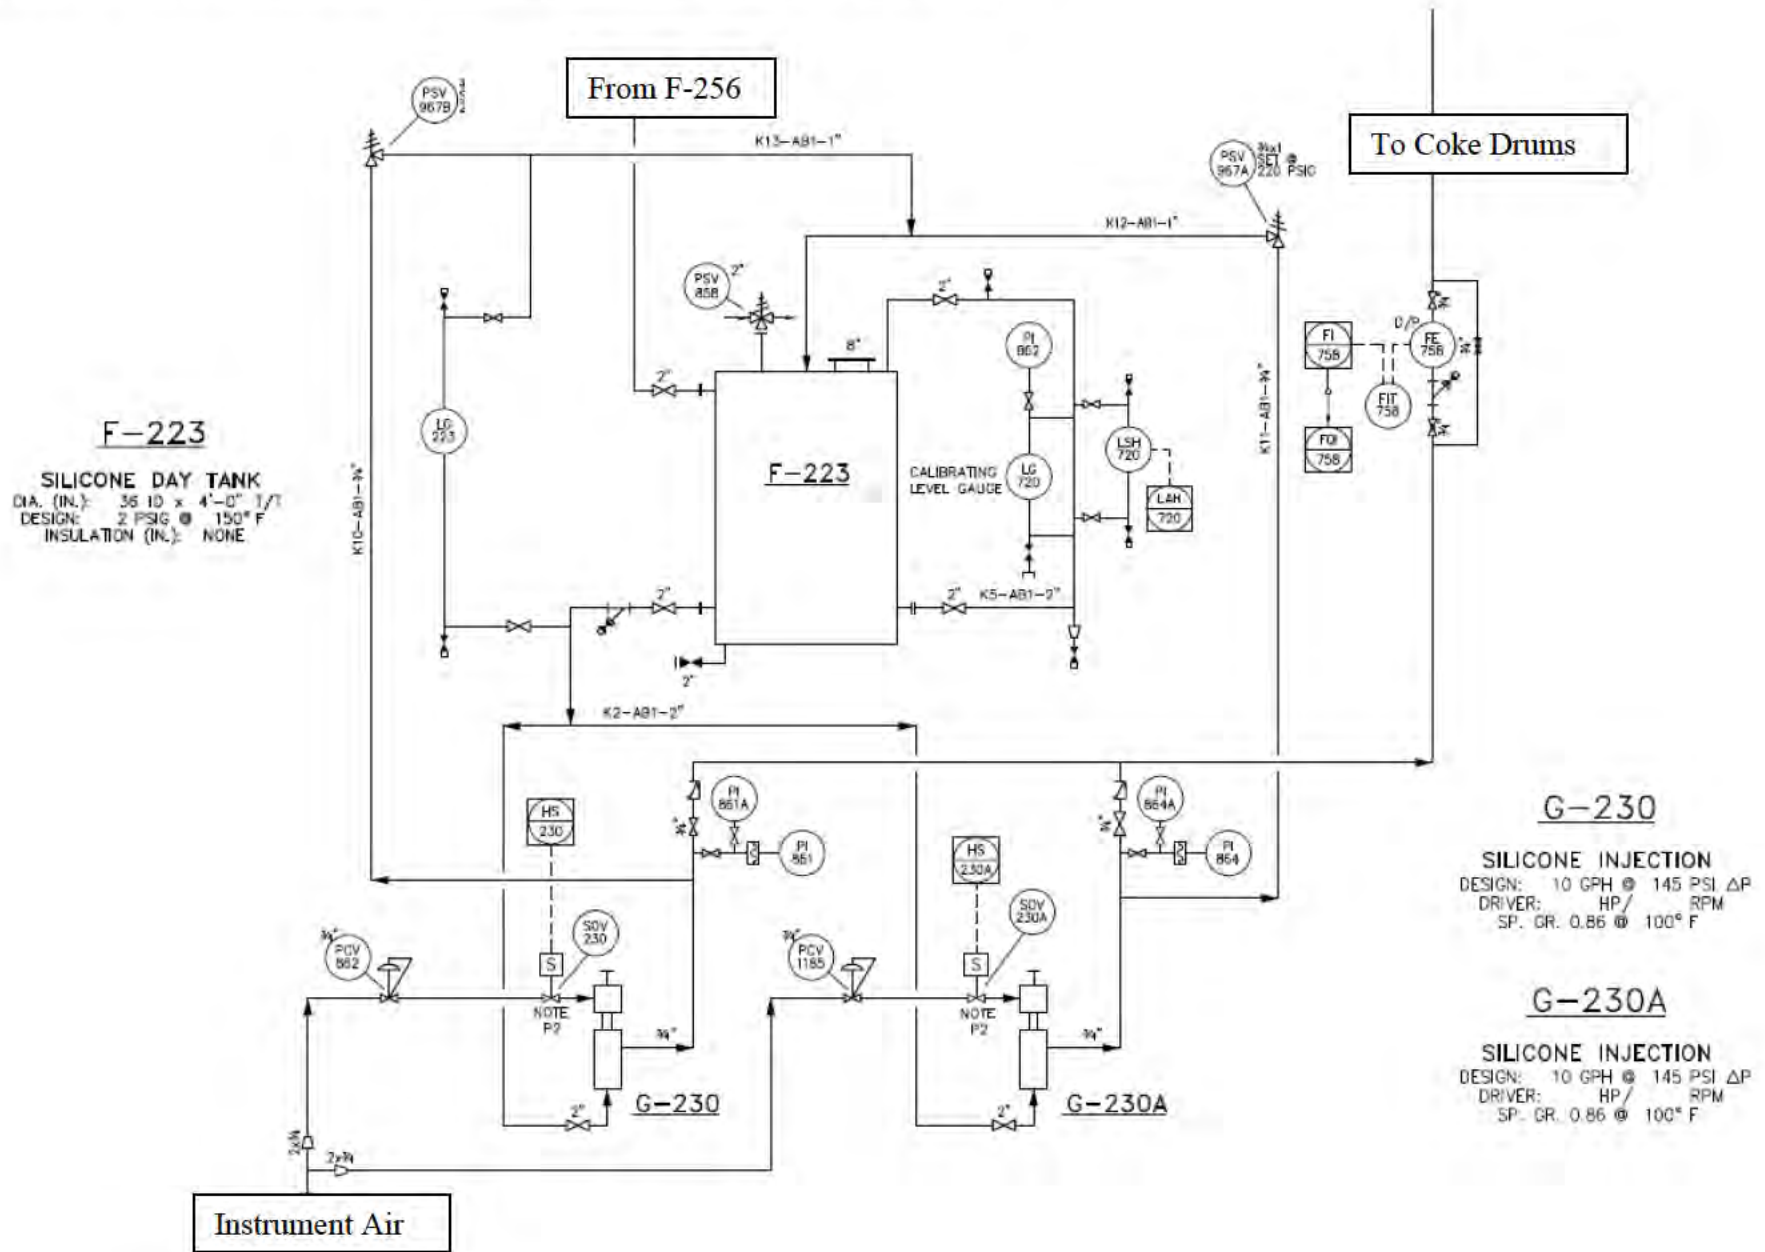
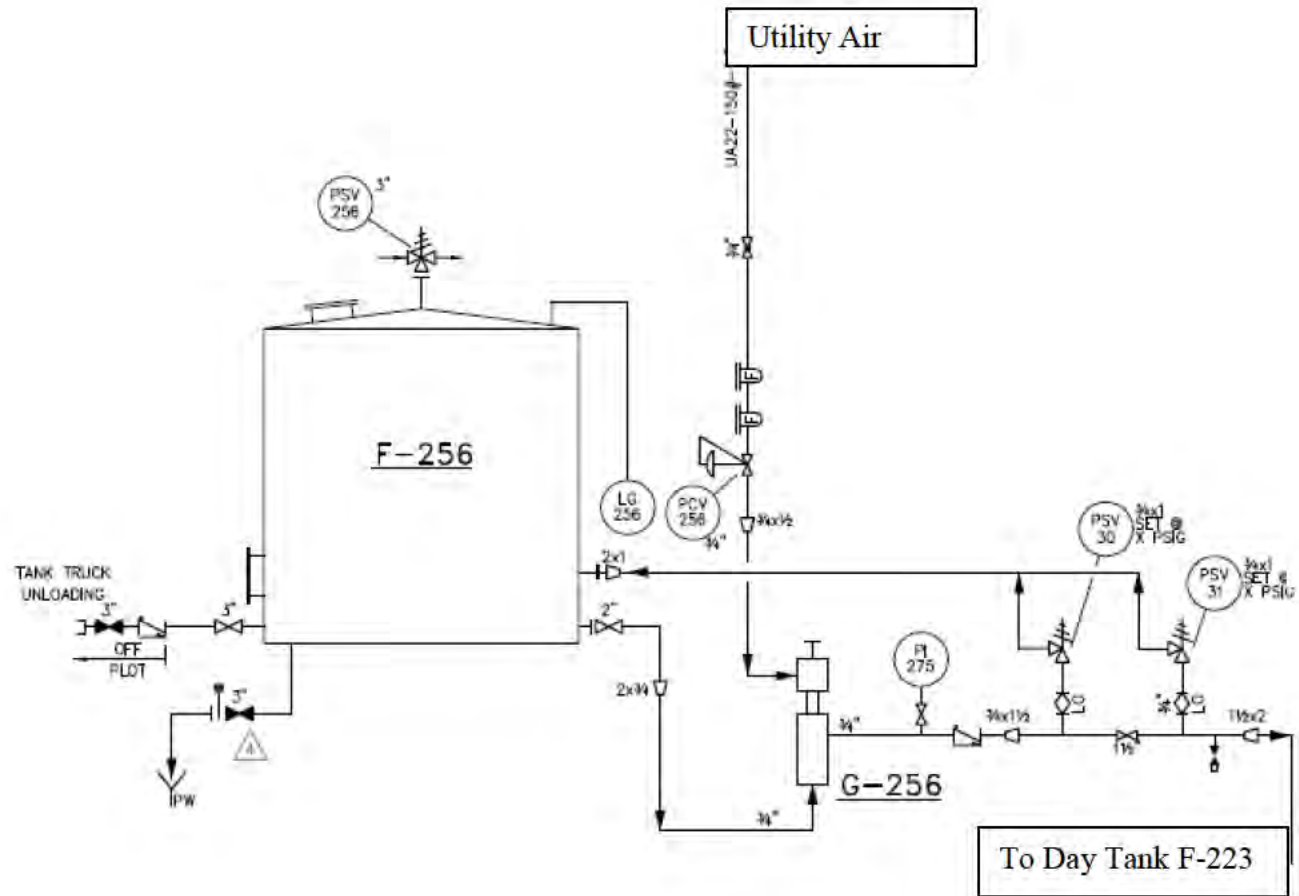
ATTACHMENT 2: Silicone System [from P&ID 0200-YD-010-004]

F-223 is filled from the F-256 Silicone Storage Tank using the G-256 Silicone Transfer pump. Both F-256 and G-256 are located at grade on the opposite side of the unit from the coke drums. G-256 is an air-motor driven gear pump that transfers the silicone antifoam to the day tank at an estimated 20 gpm.

Eliminate the Silicone Day Tank by installing facilities to pump directly from the Bulk Storage tank to the coke drums. [RC5, 6, 7]

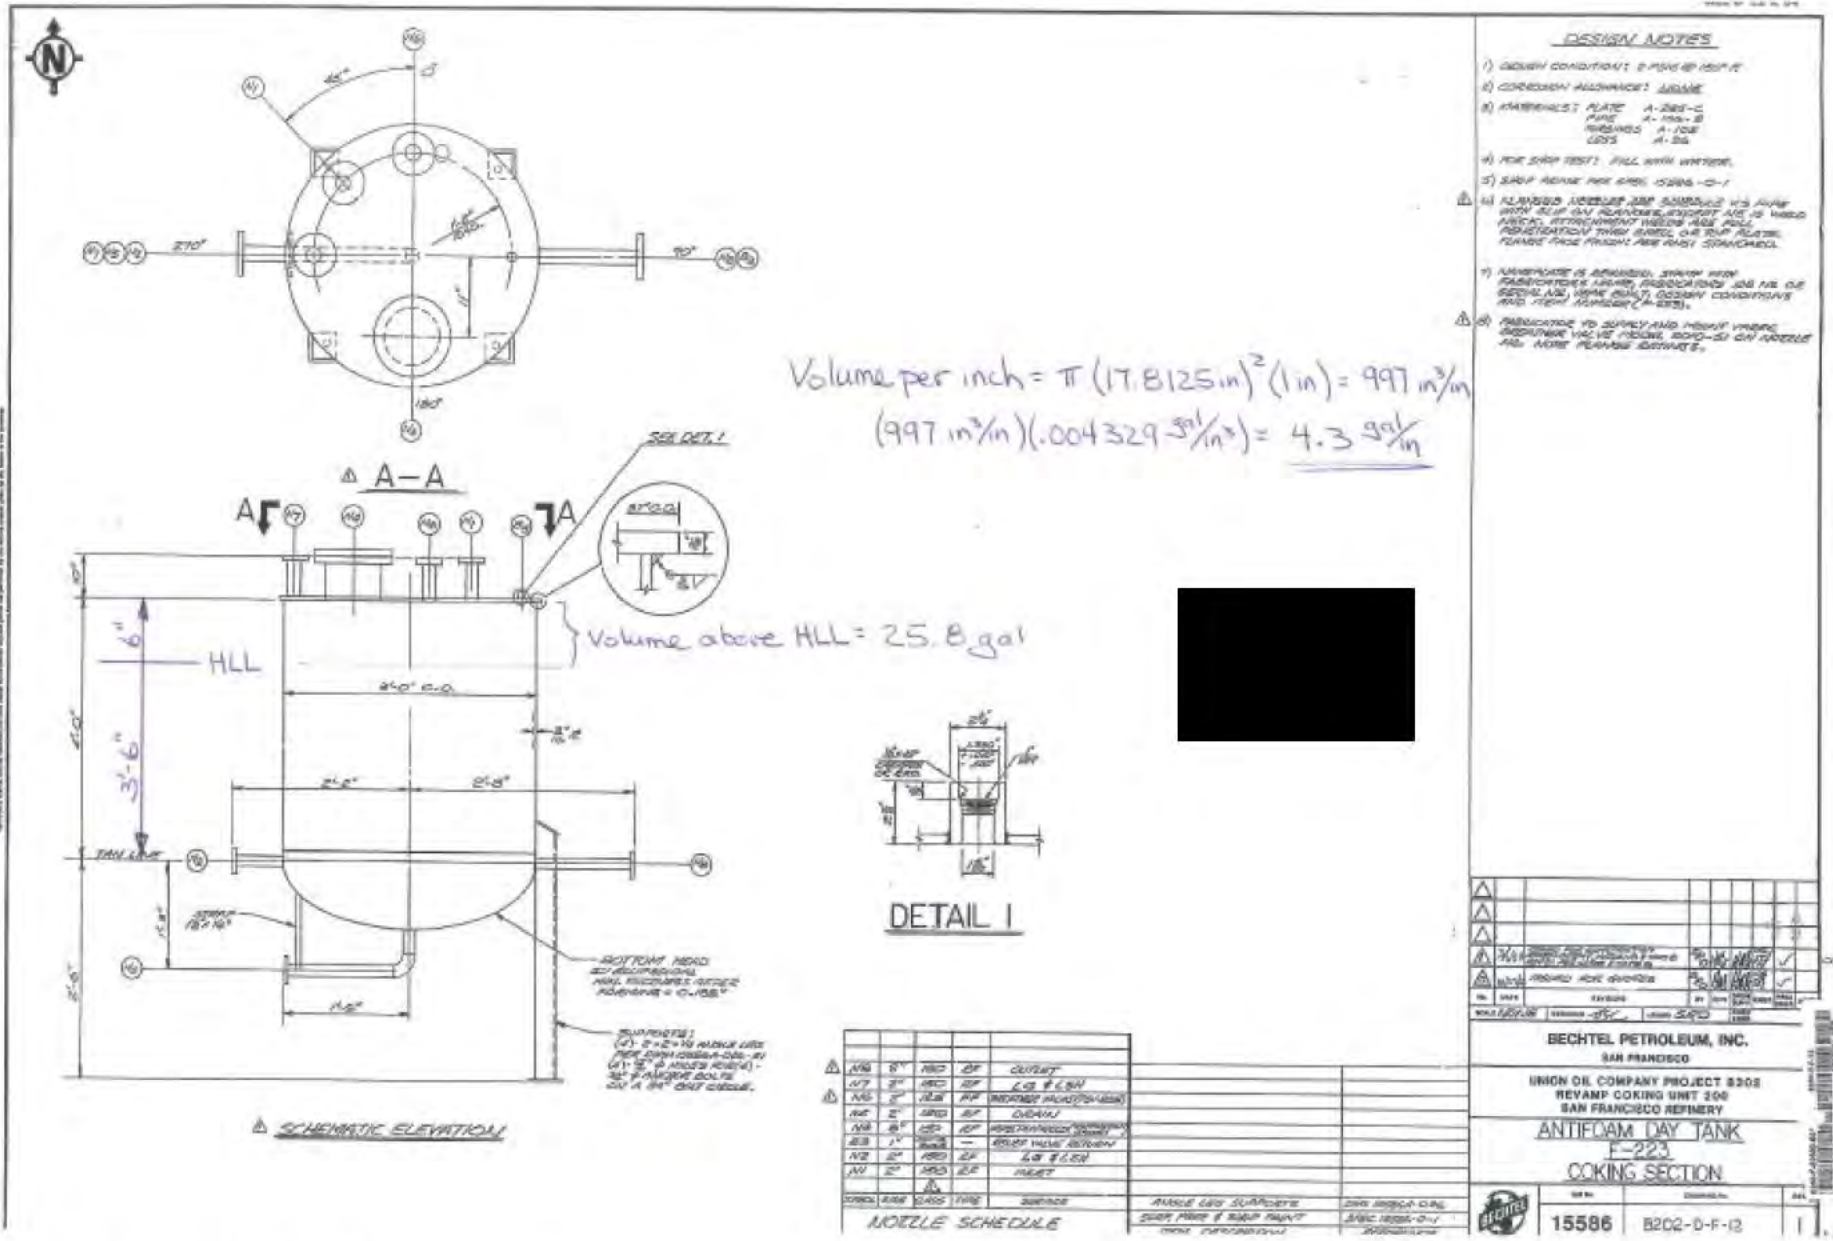
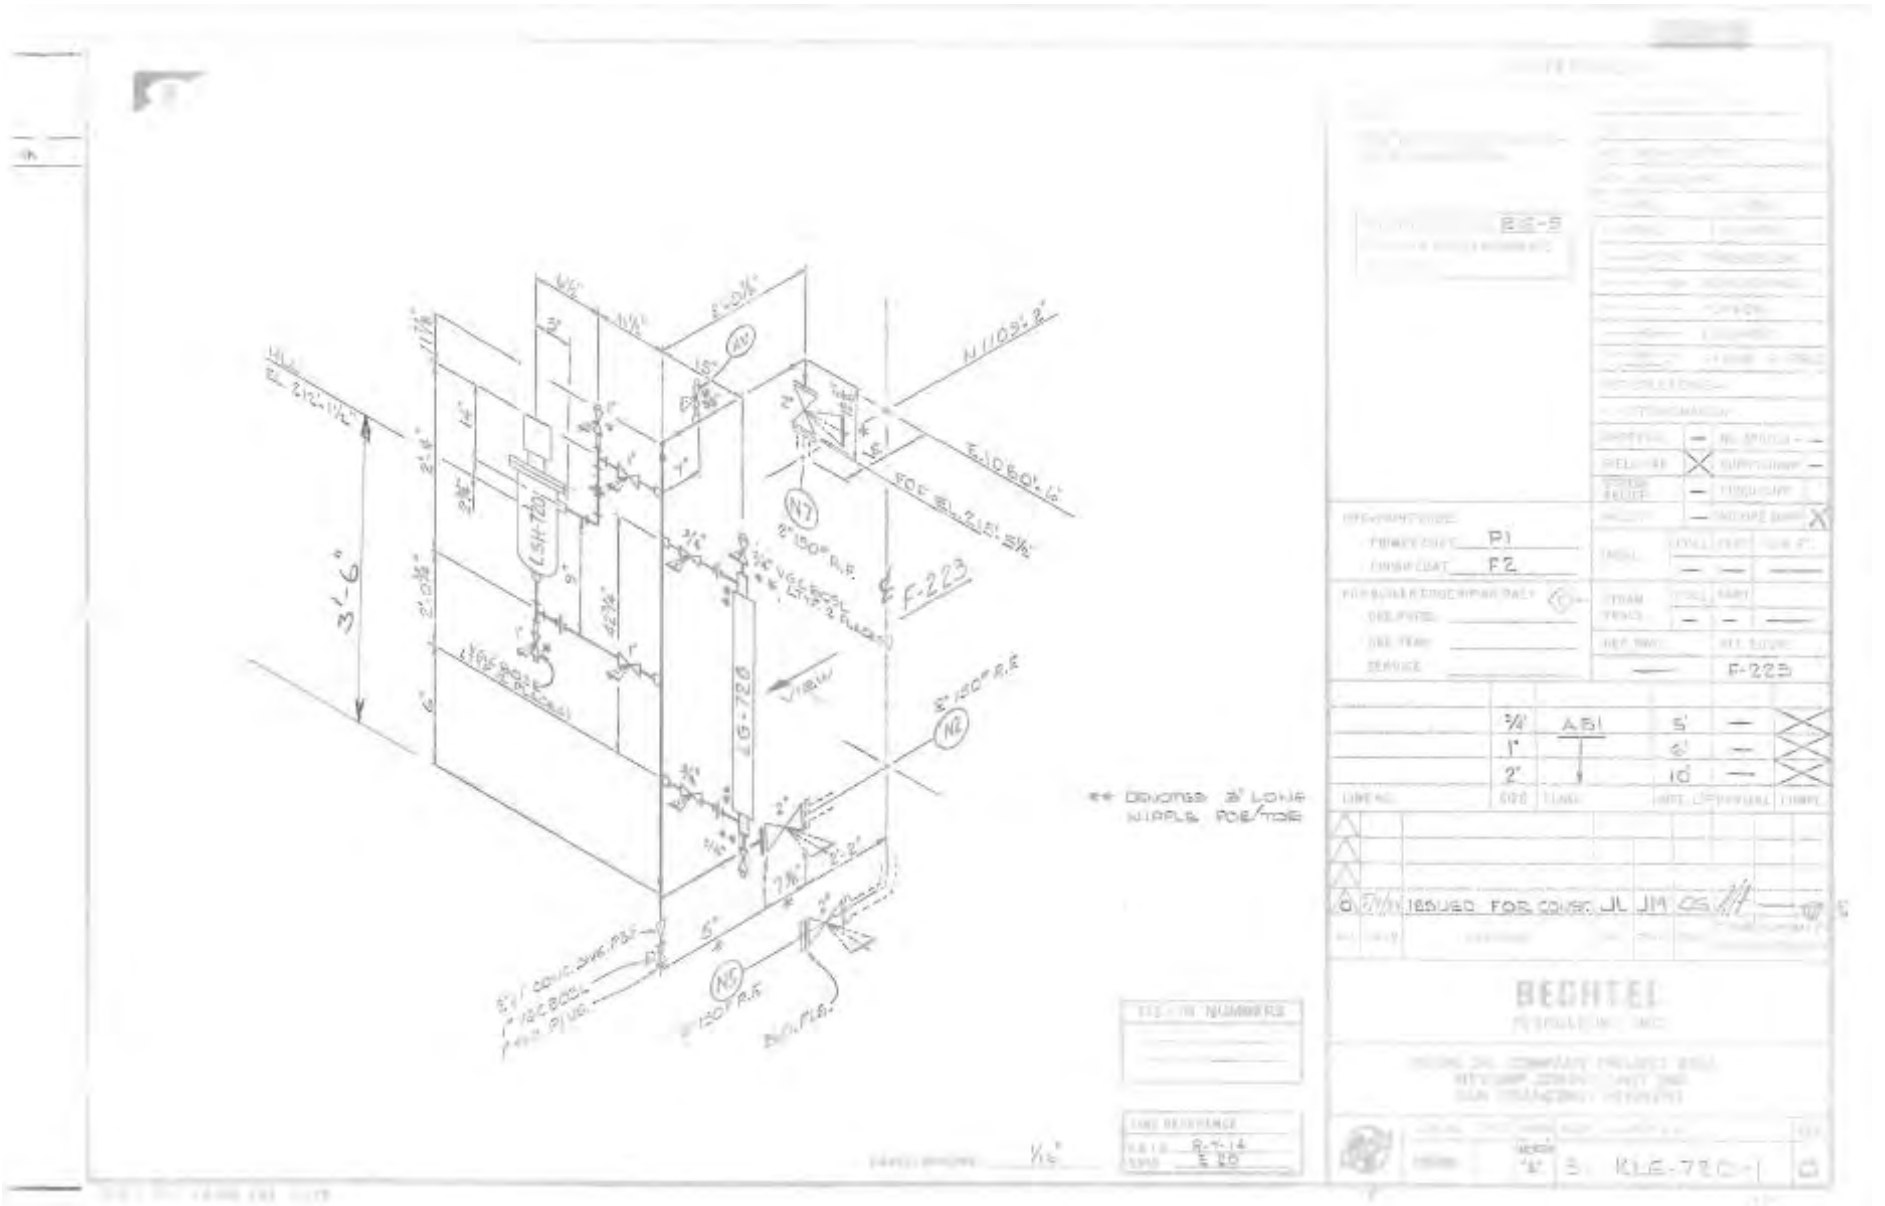
ATTACHMENT 3: Antifoam Day Tank F-223 and associated level bridle drawings

In order to prevent foaming and the carryover of coke from the coke drums into the Bubble Tower, silicone antifoam is injected into the top of the full coke drum coming off line approximately 15 minutes prior to switching the feed out of the drum. The silicone antifoam injection is stopped after the stripping steam is introduced into the off line coke drum. About 10 to 20 gallons of silicone antifoam are injected into the coke drum during each switch. The silicone antifoam is pumped from the F-223 Silicone Day Tank located on the top deck of the coke drum structure by one of the G-230/A Silicone Injection Pumps into the coke drum. F-223 is a small vertical tank 36" in diameter and 48" from the bottom tangent to the top of the tank and holds approximately 200 gallons (see attached drawings for details). The tank has a breather valve, PSV-858, mounted on a 2" nozzle on the top of the tank. F-223 is equipped with a sight glass with scale and a DCS high level alarm, LAH-720 that activates at 6" below the top of the tank.

The F-223 high level alarm field device, LSH-720, has a history of maintenance problems resulting in nuisance alarms. On July 1, 2014 LAH-720 was disabled per procedure RNOP-400-OPS, "Disabling / Enabling of DCS alarms." LAH-720 remained disabled and was still disabled at the time of the incident. LAH-720 was included on the U200 Plant Disabled Alarm List that was reviewed monthly by the Unit 200 engineer, Unit 200 area supervisor, and the PCA engineer October 2014 through July 2015. There were no monthly reviews July to September 2014 due to the unavailability of review team members. Because of the low risk and likelihood of F-223 experiencing a high level, as an operator is normally standing by F-223 when it is being filled, the review team assigned a low priority to repairing LSH-720. There are records of

Modify the Rodeo Refinery Alarm Guide Policy 07.0-12 to add a requirement for a higher level of review of all disabled alarms that have been on the monthly report for an extended time period. [RC8]

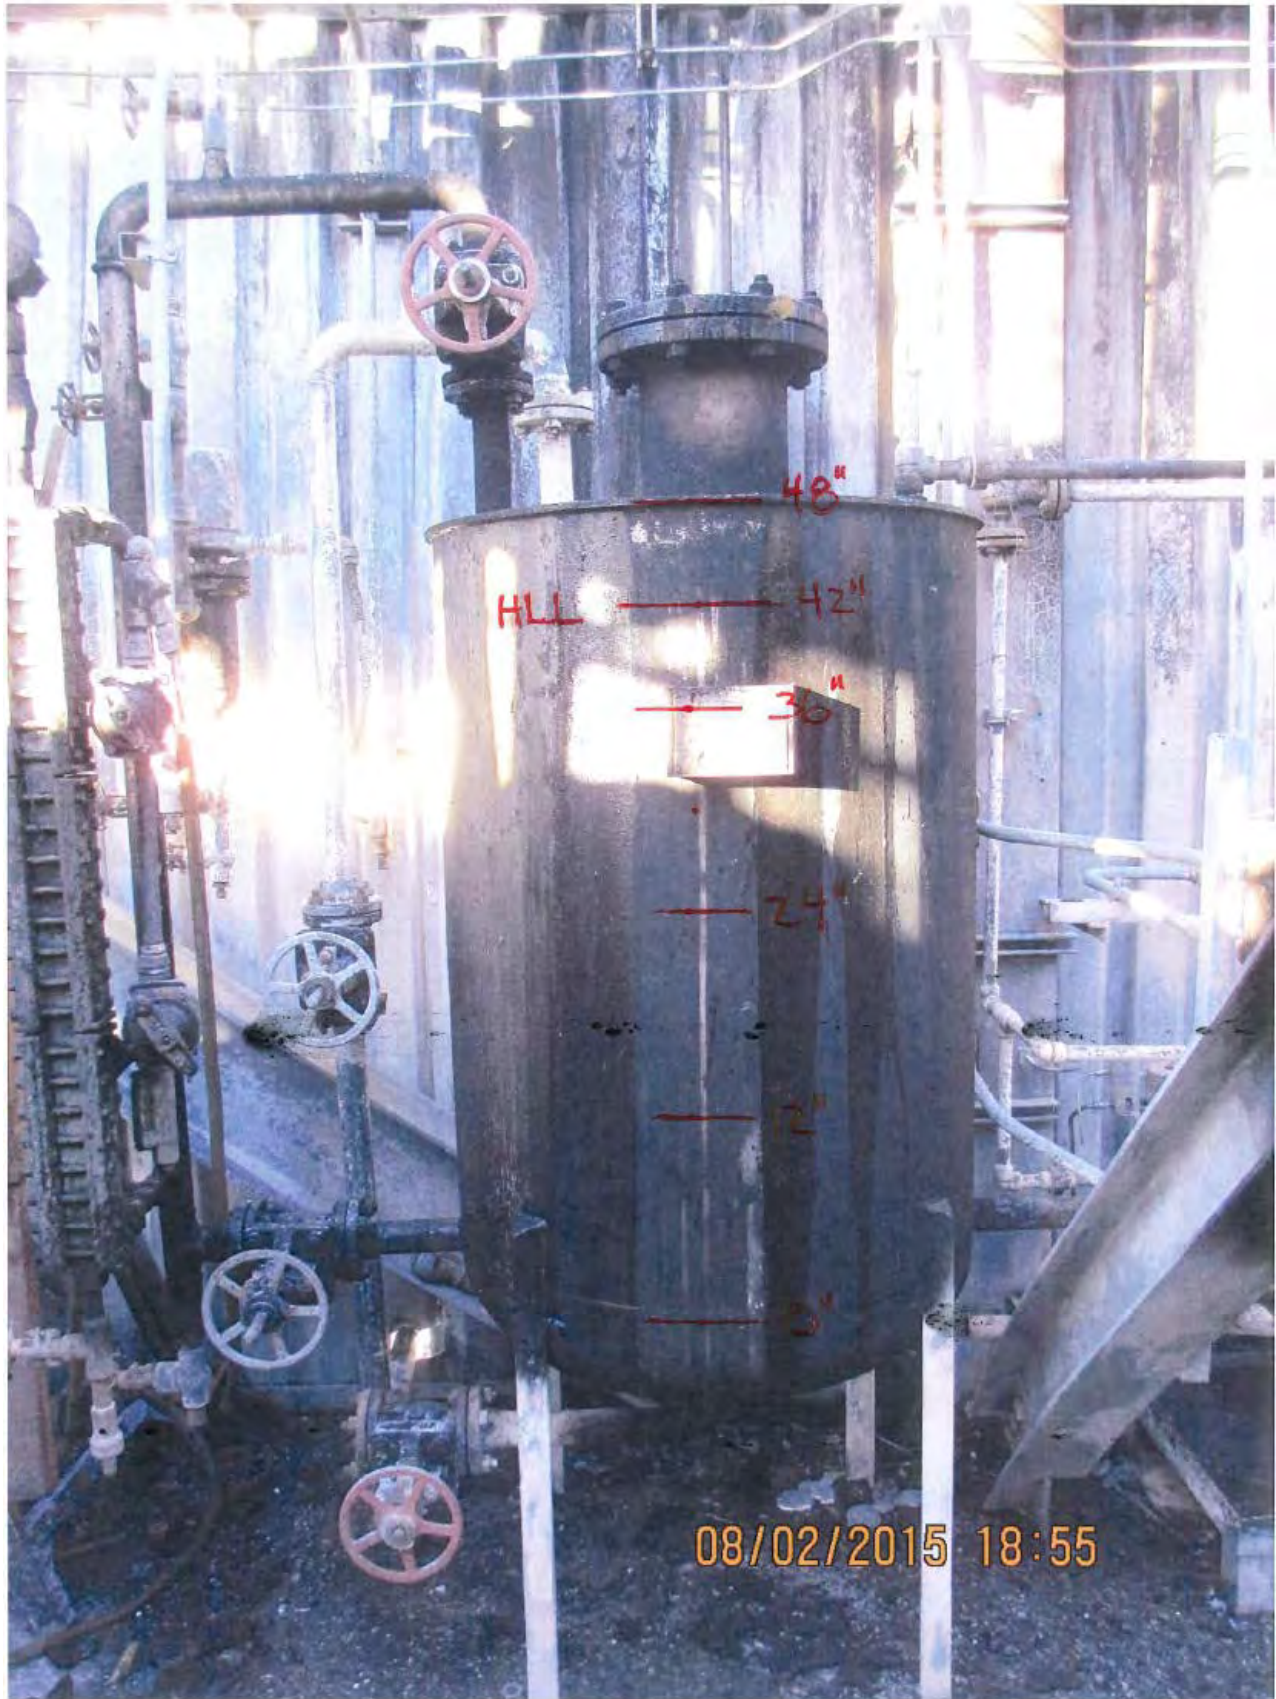
ATTACHMENT 4: PHOTOGRAPH

The physical cause of this incident was the overflow of the silicone antifoam liquid, a class 3 flammable liquid, from the 200 gallon F-223 Silicone Day Tank onto the coke drum top deck.

On day shift Sunday, August 2 some time prior to the incident the operator decoking coke drum D203 observed the level in the F-223 to be about 30”.

PICTURE OF DAY TANK WITH LEVELS MARKED
