# Shell Oil Products US

Re: 30-day Report for 12/19/16 Incident (Partial Power Outage and Flaring)

## Investigation Report

### **Loss of Power to Substations 1203 & 1206**

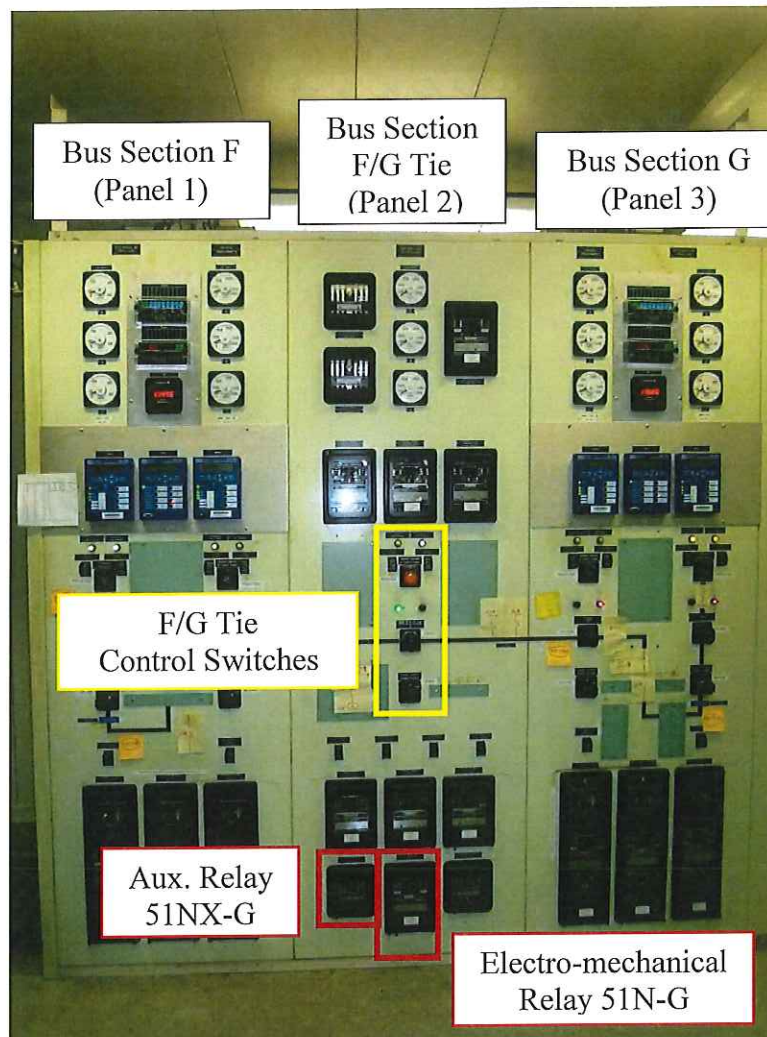
The auxiliary relay 51NX-G and the electro-mechanical relay 51N-G are both located on the “12kV Bus Sectionalizing F&G” panel (Panel 2). The E.S. believed that manually closing auxiliary relay 51NX-G was safe from consequence, because the E.S. believed the F/G Tie breaker components located on Panel 2 were isolated from the neighboring panels, Bus Section F, 1600/2 (Panel 1) and Bus Section G, 1700/2 (Panel 3). The labeling of the components on Panel 2 corresponded to the F/G Tie breaker and typically panels were organized by their associated components. The E.S. also had reason to believe that manually closing auxiliary relay 51NX-G on Panel 2 was safe from consequence, because the outdoor F/G Tie breaker was physically isolated from Bus Section G and F when the isolation switches were manually opened in the field. See photo below of Panel 2 inside Sub 1.

Figure 1: Panels inside Sub 1

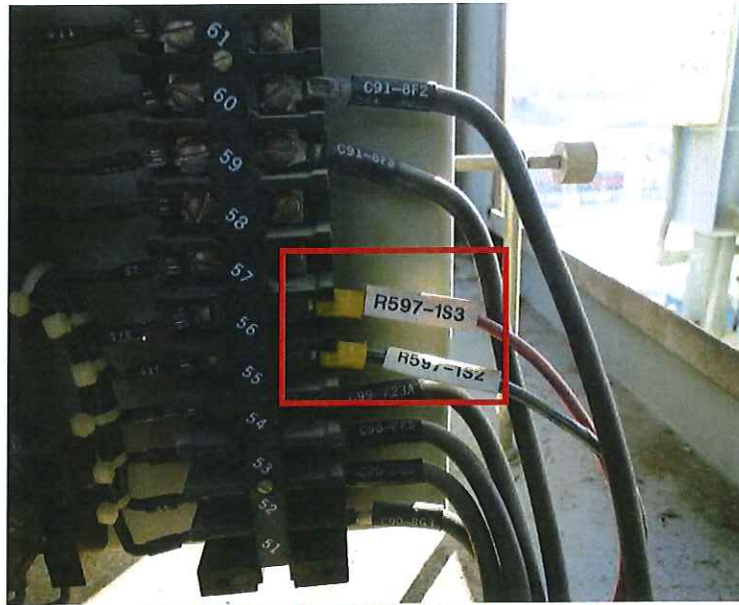
Lastly, the E.S. had followed out the wires from his initial troubleshooting from the outdoor F/G Tie breaker into Sub 1 control building. These wires were chosen, because the E.S. was aware of the alarm and F/G Tie breaker issue on December 13<sup>th</sup> and was looking for wiring that ran external from the F/G Tie breaker to Panel 2 in Sub 1 control building. The wires were traced out and believed to land on a terminal block at the back of Panel 2, and were subsequently traced to auxiliary relay 51NX-G. The wires that were identified and traced to the back of Panel 2 were distinctive from the other wires, internal and external to the F/G Tie breaker and Panel 2, in that: they were a pair of red and black wires, the wires had similar gauge, wire numbers, wire tags, and yellow wire lugs. See photo below of wires that were traced from the outdoor F/G Tie breaker to the back of Panel 2.

Figure 2 Wires from F/G Tie breaker internals

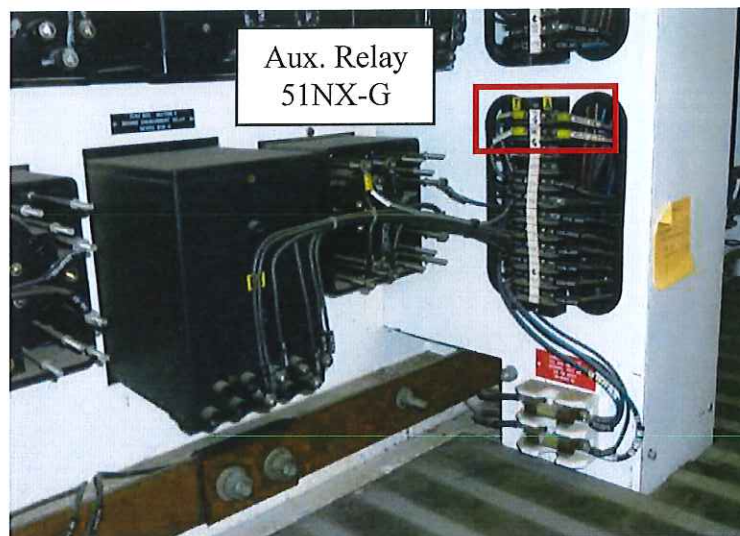
Figure 3 Wires on terminal strip at back of Panel 2

Although isolated physically in the field, auxiliary relay 51NX-G, located on Panel 2, had active wiring to trip Bus Section G's main breaker (1700/2) when manually pushed into the closed position.
