# Shell Oil Products US

Re: 30-day Report for 12/19/16 Incident (Partial Power Outage and Flaring)

## Investigation Report

### **Loss of Power to Substations 1203 & 1206**

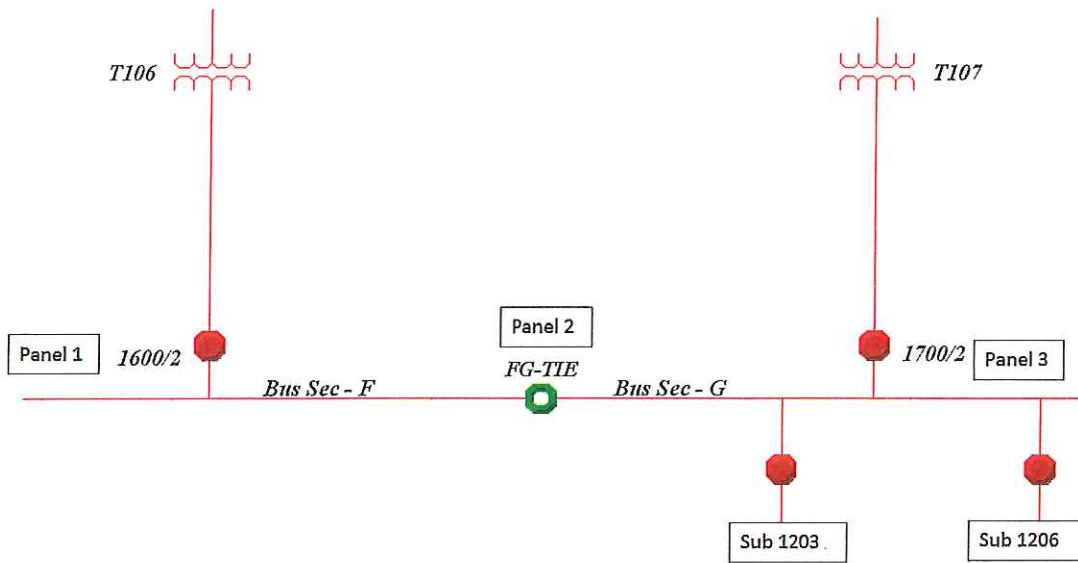
# Sub 1

It was determined that Bus Section G main breaker (1700/2) tripped, resulting in loss of power to Subs 1203 and 1206, due to the manual closing of auxiliary relay's (51NX-G) contacts, which sent a trip signal to Bus Section G main breaker (1700/2). The investigation team focused the investigation on the human interfacing and decision making to determine the causes as to why the E.S. manually interacted with auxiliary relay (51NX-G).
